# TECHNICAL MEMORANDUM

**Date:** 2025-Jul-25 **File No.:** 241207  
**To:** Jason Brake **From:** Doug Power, P.Eng.  
Manager of Infrastructure Support DTI Sr. Eng.  
**Subject:** Supplement to 2024 Inspection Report - NL DTI Wharf at Red Bay (Final)  
**Rev:** 00

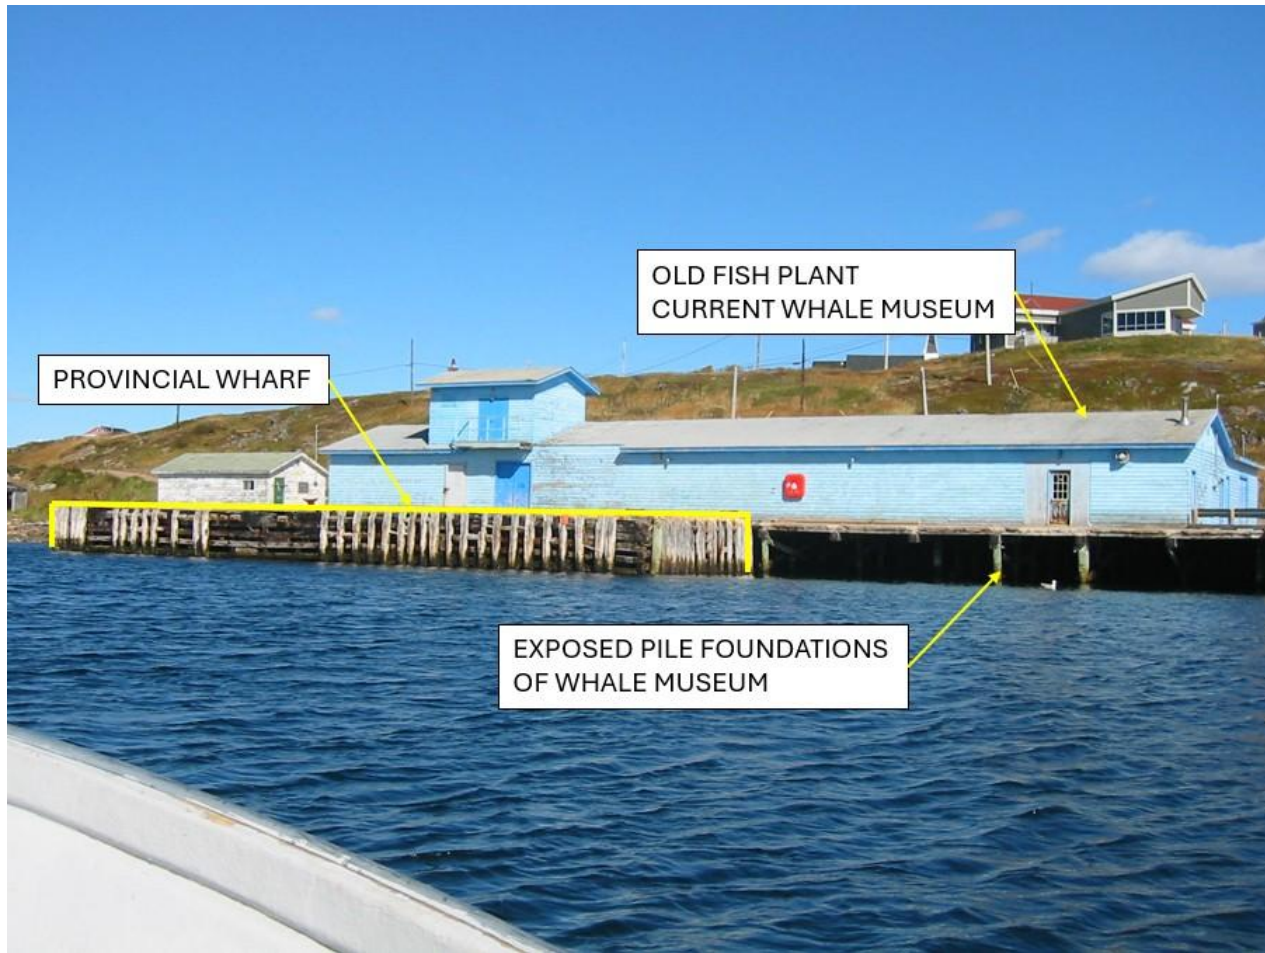
As per our 2024 memo we emphasize that the Provincial wharf does play a role in protecting the piled foundations of the wharf which supports Right Whale Exhibit Museum on the upland side from sea ice loading. If the Provincial Wharf is removed additional construction measures will be required to protect the piled foundations beneath the Right Whale Museum possibly involving reconstruction of a narrower wharf in the footprint of the existing Provincial wharf or driving fender piles around the remaining perimeter to shelter the foundations of the Whale Museum Building from ice loading. We have provided below a picture shared from 2006 when the foundations of the Whale Museum were partially exposed to the south of the Provincial wharf.
