GOVERNMENT OF NEWFOUNDLAND AND LABRADOR Department of Transportation and Infrastructure	<b>BRIDGE INSPECTION REPORT</b> <b>B05282019-1</b>																	
<b>Date:</b> 5/28/2019	<b>Inspected By:</b> Pickett R	<b>Category:</b> Eng. - Engineering																	
<b>BRIDGE INFORMATION</b>																			
<b>Site:</b>	1-303 - ASSUMPTION CEMETARY BRIDGE																		
<b>Route:</b>		<b>Overall Length:</b>	7.9 m																
<b>Year Built:</b>	1945	<b>Est:</b> Yes	<b>Overall Width:</b> 11.1 m																
<b>Year Last Rehab.:</b>	1975	<b>Est:</b> Yes	<b>Roadway Width:</b> 8.5 m																
<b>Region:</b>	AVALON PENINSULA		<b>Sidewalk Width:</b> 0 m																
<b>Jurisdiction:</b>	Provincial		<b>Clearance to R.D. or N.W.L.:</b> 1 m																
<b>Type of Structure:</b>	04 - Rigid Frame		<b>Max Depth of N.W.L.:</b> 0.2 m																
<b>Purpose of Structure:</b>	04 - Over Non-Navigable Waters		<b>Spans:</b>																
<b>Type of Handrail:</b>	01 - Aluminum Rail

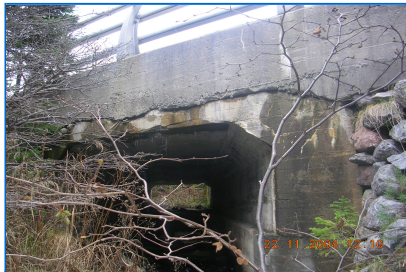
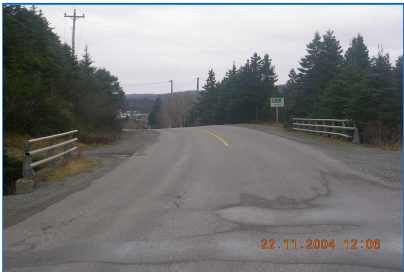
<b>SUBSTRUCTURE</b>																			
<b>Condition:</b>	F1 - Fair	<b>Bearings:</b>	I - Inapplicable																
		<b>Bearing Seat:</b>	I - Inapplicable																
<b>Comments:</b>	Light erosion and medium cracks to frame leg footing. Rehabbed and scour required 2017.																		
<b>SUPERSTRUCTURE</b>																			
<b>Condition:</b>	F2 - Fair	<b>Expansion Joints:</b>	I - Inapplicable																
<b>Comments:</b>	Narrow vertical cracks with light efflor deposit in faces of frame legs. Wide movement crack at North East corner of east frame leg. Water leaking between extension and original joint.																		
<b>DECK</b>																			
<b>Condition:</b>	F2 - Fair	<b>Curbs:</b>	F2 - Fair																
<b>Hand Rail:</b>	G - Good	<b>Roadway Condition:</b>	F2 - Fair

<b>Approach Rail:</b>	G - Good		
<b>Comments:</b>	All handrail replaced 2017. New hazard markers installed. Medium longitudinal cracks with light efflorescence deposits on deck soffit.		
<b>HYDROLOGY</b>			
<b>Water Velocity:</b>	0.3 m/s	<b>Ice Problem:</b>	N - No Problem
<b>Water Depth:</b>	0.2 m	<b>Scour Problem:</b>	N - No Problem
<b>Waterway:</b>	01 - Adequate	<b>Debris Problem:</b>	N - No Problem
<b>Comments:</b>			
<b>REPLACEMENT/REHABILITATION</b>			
<b>Next Rehab. Date:</b>	2019	<b>Replacement Year:</b>	2030
<b>Antic. Rehab. Cost:</b>	\$0	<b>Replacement Cost:</b>	\$500
<b>Recommendations:</b>			
<b>OBSERVATIONS</b>			
<b>Overall Condition:</b>	F2 - Fair	<b>Requires Further Inspection:</b>	No
<b>Additional Observations:</b>			
<b>LEGEND:</b>			
<b>Condition Definitions:</b>		<b>Problem Definitions:</b>	
1 - *Good - [discontinued code].	F2 - Fair.	C - Unsafe (Closed to Public).	N - No Problem.
2 - *Fair - [discontinued code].	F1 - Fair.	U - Uninspectable.	P - Possible Problem.
