GOVERNMENT OF NEWFOUNDLAND AND LABRADOR Department of Transportation and Infrastructure	BRIDGE INSPECTION REPORT B09092021-2	
Date: 3/13/2020	Inspected By: Chris Lyver	Category: Eng. - Engineering	
BRIDGE INFORMATION			
Site:	1-093 - BALDWIN'S RIVER BRIDGE, SE PLACENTIA		
Route:	91	Overall Length:	15.3 m
Year Built:	1964	Est: No	Overall Width: 8.6 m
Year Last Rehab.:		Est: No	Roadway Width: 8 m
Region:	AVALON PENINSULA	Sidewalk Width:	0.3 m
Jurisdiction:	Provincial	Clearance to R.D. or N.W.L.:	3.2 m
Type of Structure:	03 - Reinforced Concrete Beam/Slab	Max Depth of N.W.L.:	0.3 m
Purpose of Structure:	04 - Over Non-Navigable Waters	Spans:	
Type of Handrail:	02 - Concrete Rail	<u>Span No.:</u>	<u>Length</u>
Roadway Surface:	02 - Asphalt	1	7
Alignment Vertical:	02 - Adequate	2	0
Alignment Horizontal:	02 - Adequate	3	0
Restrictions:	No	<u>Span No.:</u>	<u>Length</u>
		4	0
		5	0
		6	0
BRIDGE PHOTOS

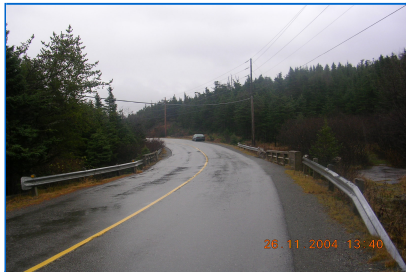
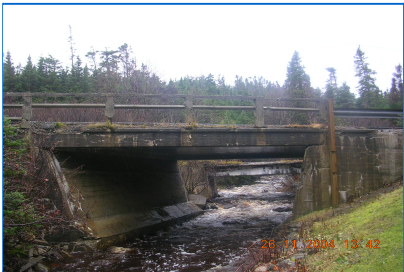
SUBSTRUCTURE			
Condition:	P3 - Poor	Bearings:	F1 - Fair
		Bearing Seat:	F1 - Fair
Comments:	- Medium erosion along faces of both abut. footings. - Medium horizontal/vertical cracks with med. efflor. deposits in 4 wings. - Medium/wide vert./horizontal cracks in face in both footings. - Severe spalling/disintegration to D/S ends of both abutments - Medium vert cracks in face of east abut. med scour under footings - Wide vertical crack in face of west abut.		
SUPERSTRUCTURE			
Condition:	P3 - Poor	Expansion Joints:	P3 - Poor
Comments:	- No visible signs of expansion joints. - Wide vert./horiz. cracks with medium efflor. deposits in 2 exterior beams.		
DECK			
Condition:	F1 - Fair	Curbs:	F1 - Fair

Hand Rail:	P - Poor	Roadway Condition:	F1 - Fair
Approach Rail:	F1 - Fair		
Comments:	- Handrail - P (D/S, F2 (U/S). - Severe damage remains to D/S steel tube/guiderail posts. (top steel tube rail not attached to tipped and sheared off posts, held on with steel chain) - Medium damage to NW exit guiderail. - Light delamin./spalling to deck/curb fascia. - Several areas of medium delamin./spalling with medium rusting to exposed reinf. on deck soffit. - Haz. marker at NW end damaged

Next Rehab. Date:	2020	Replacement Year:	2030
Antic. Rehab. Cost:	\$75	Replacement Cost:	\$900
Recommendations:	- Repair all concrete defects - Repair D/S handrails ASAP - Resurface deck and approaches. Repair/replace NW exit guiderail - Install new hazard markers at NW and SW ends
