GOVERNMENT OF NEWFOUNDLAND AND LABRADOR Department of Transportation and Infrastructure	BRIDGE INSPECTION REPORT B11192021-2	
Date: 10/22/2021	Inspected By: Mike Button	Category: Office - Bridge Office	
BRIDGE INFORMATION			
Site:	1-028 - BRANCH CAUSEWAY BRDG, CAPE SHORE RD		
Route:	100	Overall Length:	47.7 m
Year Built:	1971	Est: No	Overall Width: 9.6 m
Year Last Rehab.:		Est: No	Roadway Width: 8 m
Region:	AVALON PENINSULA	Sidewalk Width:	0.8 m
Jurisdiction:	Provincial	Clearance to R.D. or N.W.L.:	3.1 m
Type of Structure:	01 - AASH to Girder	Max Depth of N.W.L.:	3.3 m
Purpose of Structure:	04 - Over Non-Navigable Waters	Spans:	
Type of Handrail:	02 - Concrete Rail	Span No.:	Length
Roadway Surface:	02 - Asphalt	Span No.:	Length
Alignment Vertical:	01 - Good	1	36.1
Alignment Horizontal:	01 - Good	2	0
Restrictions:	No	3	0
		4	0
		5	0
		6	0
BRIDGE PHOTOS

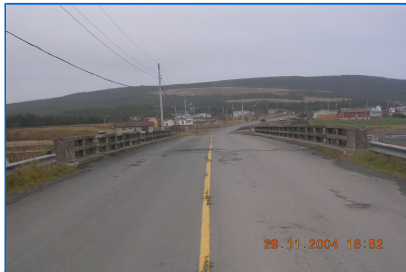
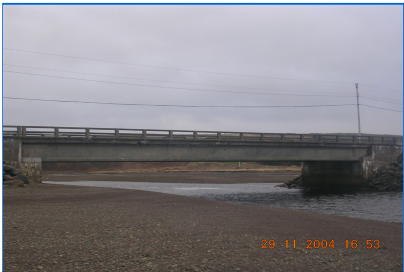
Additional Observations: - Waterline attached to the upstream (north side of structure). - Hazards, mild traffic and working around water. Bridge in overall poor condition and needs replacement.

Next Rehab. Date:		Replacement Year:	2026
Antic. Rehab. Cost:	\$REPLACE	Replacement Cost:	\$2,500,000
Recommendations:	- Replace the structure within 5 years.
