GOVERNMENT OF NEWFOUNDLAND AND LABRADOR Department of Transportation and Infrastructure	<b>BRIDGE INSPECTION REPORT</b> <b>B06282019-5</b>	
<b>Date:</b> 6/28/2019	<b>Inspected By:</b> Hunt R	<b>Category:</b> Eng. - Engineering	
<b>BRIDGE INFORMATION</b>			
<b>Site:</b>	1-253 - BRAZIL'S HILL BRIDGE #2, SPANIARDS B		
<b>Route:</b>	70	<b>Overall Length:</b>	8.8 m
<b>Year Built:</b>	1965	<b>Est: Yes</b>	<b>Overall Width:</b> 28.8 m
<b>Year Last Rehab.:</b>		<b>Est: No</b>	<b>Roadway Width:</b> 22 m
<b>Region:</b>	AVALON PENINSULA	<b>Sidewalk Width:</b>	0 m
<b>Jurisdiction:</b>	Provincial	<b>Clearance to R.D. or N.W.L.:</b>	2 m
<b>Type of Structure:</b>	04 - Rigid Frame	<b>Max Depth of N.W.L.:</b>	0.3 m
<b>Purpose of Structure:</b>	04 - Over Non-Navigable Waters	<b>Spans:</b>	
<b>Type of Handrail:</b>	02 - Concrete Rail	<u>Span No.:</u>	<u>Length</u>
<b>Roadway Surface:</b>	02 - Asphalt	1	6.4
<b>Alignment Vertical:</b>	01 - Good	2	0

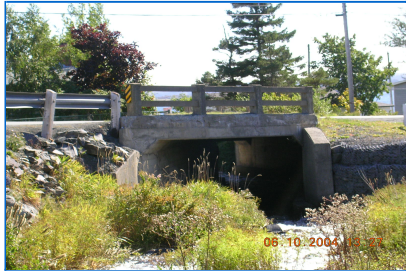
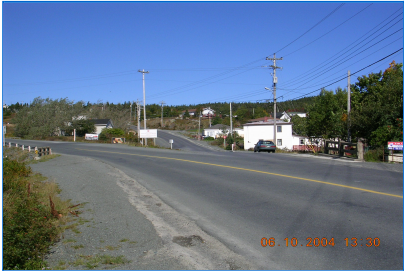
<b>SUBSTRUCTURE</b>			
<b>Condition:</b>	P3 - Poor	<b>Bearings:</b>	I - Inapplicable
		<b>Bearing Seat:</b>	I - Inapplicable
<b>Comments:</b>	Medium erosion to faces, tops and ends of upstream footing. Severe scour under downstream retaining wall footing. Retaining wall runs alongside private property.		
<b>SUPERSTRUCTURE</b>			
<b>Condition:</b>	P3 - Poor	<b>Expansion Joints:</b>	I - Inapplicable
<b>Comments:</b>	Severe spalling with efflor deposits and medium corrosion to exposed reinforced in frame legs at vertical construction joints between original structure and downstream extensions. Narrow vertical cracks in faces of frame legs and wingwalls retaining wall. Medium erosion at bases of upstream frame legs.		
<b>DECK</b>			
<b>Condition:</b>	P3 - Poor	<b>Curbs:</b>	P3 - Poor

<b>Hand Rail:</b>	P3 - Poor	<b>Roadway Condition:</b>	P3 - Poor
<b>Approach Rail:</b>	G - Good		
<b>Comments:</b>	Severe spalling with efflor deposits and medium severe corrosion to exposed reinforcement in deck soffit at construction joint between original structure and extensions. Medium delamination and spalling to upstream deck soffit severe spalling disintegration to tops of extension faces and curbs. Medium spalling/ wide vertical horizontal cracks with medium corrosion to exposed reinforcement on upstream concrete handrail. Downstream concrete handrail missing. New guiderail installed between structure 1 and structure 2.

<b>Next Rehab. Date:</b>	2020	<b>Replacement Year:</b>	2030
<b>Antic. Rehab. Cost:</b>	\$150	<b>Replacement Cost:</b>	\$600
<b>Recommendations:</b>	Repair scour areas at construction joints. Fix slope erosion. Install approach and exit rail and hazard markers. Bridge office should reinspect scour under downstream retaining wall and construction joints.
