GOVERNMENT OF NEWFOUNDLAND AND LABRADOR Department of Transportation and Infrastructure	BRIDGE INSPECTION REPORT B06192019-9	
Date: 6/19/2019	Inspected By: Pickett R	Category: Eng. - Engineering	
BRIDGE INFORMATION			
Site:	1-106 - BRAZIL'S HILL, SPANIARDS BAY		
Route:	70	Overall Length:	6.9 m
Year Built:	1970	Overall Width:	28.4 m
Year Last Rehab.:		Roadway Width:	23 m
Region:	AVALON PENINSULA	Sidewalk Width:	0 m
Jurisdiction:	Provincial	Clearance to R.D. or N.W.L.:	2.9 m
Type of Structure:	04 - Rigid Frame	Max Depth of N.W.L.:	0.3 m
Purpose of Structure:	04 - Over Non-Navigable Waters	Spans:	
Type of Handrail:	02 - Concrete Rail	<u>Span No.:</u>	<u>Length</u>
Roadway Surface:	02 - Asphalt	1	5.5
Alignment Vertical:	01 - Good	2	0
Alignment Horizontal:	01 - Good	3	0
Restrictions:	No	4	0
		5	0
		6	0
BRIDGE PHOTOS

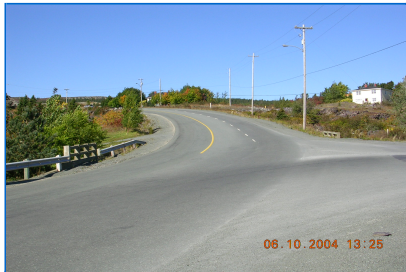
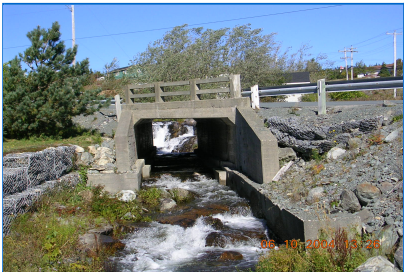
Comments:	Medium severe scour under footing at various location. Medium erosion to faces and corners of frame leg footing. Wide vertical cracks in frame leg footing.		
SUPERSTRUCTURE			
Condition:	P3 - Poor	Expansion Joints:	I - Inapplicable
Comments:	Severe spalling and disintegration with corrosion to exposed rebar in frame legs especially at construction joints. Wide vertical cracks in North West wingwall. Effloresce deposits on leg construction joint. Alligator cracking in frame legs with medium honey combing in frame legs.		
DECK			
Condition:	P1 - Poor	Curbs:	I - Inapplicable

Hand Rail:	P3 - Poor	Roadway Condition:	I - Inapplicable
Approach Rail:	F1 - Fair		
Comments:	Very severe spalling disintegration at construction joints in soffit with exposed rebar and efflorence deposits. Upstream handrail has spalling.		
HYDROLOGY			
Water Velocity:	0.5 m/s	Ice Problem:	N - No Problem
Water Depth:	0.3 m	Scour Problem:	K - Known Problem
Waterway:	01 - Adequate	Debris Problem:	N - No Problem
Comments:			
REPLACEMENT/REHABILITATION			
Next Rehab. Date:	2020	Replacement Year:	2030
Antic. Rehab. Cost:	\$50	Replacement Cost:	\$500
Recommendations:	Repair scour and deck soffit defects as well as frame leg and concrete handrail.		
OBSERVATIONS			
Overall Condition:	P3 - Poor	Requires Further Inspection:	Yes
Additional Observations:			
LEGEND:			
Condition Definitions:		Problem Definitions:	
1 - *Good - [discontinued code].	F2 - Fair.	C - Unsafe (Closed to Public).	N - No Problem.
2 - *Fair - [discontinued code].	F1 - Fair.	U - Uninspectable.	P - Possible Problem.
