GOVERNMENT OF NEWFOUNDLAND AND LABRADOR Department of Transportation and Infrastructure	BRIDGE INSPECTION REPORT B01152018-5	
Date: 1/12/2018	Inspected By: Rodger Hussey	Category: Eng. - Engineering	
BRIDGE INFORMATION			
Site:	1-197 - BROWNSDALE BROOK BRIDGE		
Route:		Overall Length:	7.5 m
Year Built:	1960	Est: No	Overall Width: 10.9 m
Year Last Rehab.:		Est: No	Roadway Width: 7.3 m
Region:	AVALON PENINSULA	Sidewalk Width:	0.3 m
Jurisdiction:	Provincial	Clearance to R.D. or N.W.L.:	1.8 m
Type of Structure:	04 - Rigid Frame	Max Depth of N.W.L.:	0.5 m
Purpose of Structure:	04 - Over Non-Navigable Waters		
Type of Handrail:	02 - Concrete Rail	Spans:	
Roadway Surface:	02 - Asphalt	<u>Span No.:</u>	<u>Length</u>
Alignment Vertical:	02 - Adequate	1	6.3
Alignment Horizontal:	02 - Adequate	2	0
Restrictions:	No	3	0
		<u>Span No.:</u>	<u>Length</u>
		4	0
		5	0
		6	0
BRIDGE PHOTOS

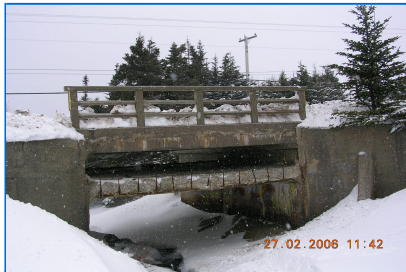
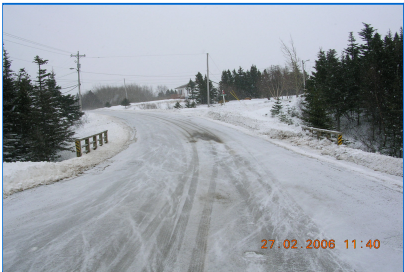
Bearing Seat:	I - Inapplicable
Comments:	No footings, frame legs poured directly onto doweled bedrock. Original structure extended approximately 5m downstream. Original deck (badly deteriorated) still in place approx. 0.8m below new deck.		
SUPERSTRUCTURE			
Condition:	P1 - Poor	Expansion Joints:	I - Inapplicable
Comments:	P1 : Original structure, F1: Extension. Numerous wide horizontal/vertical cracks with heavy efflorescence deposits in faces of original frame legs. Severe spalling to NE corner of original north frame leg. Very severe spalling/disintegration to SE corner of original south frame leg. Wide vertical crack in face of NW wingwall under shifted concrete handrail post. Construction joints between wingwalls & frame legs opening up.		
DECK

Condition:	P1 - Poor	Curbs:	P3 - Poor
Hand Rail:	P1 - Poor	Roadway Condition:	P3 - Poor
Approach Rail:	F2 - Fair		
Comments:	P1 : Extension deck fascia, F1: remainder. Narrow transverse cracks with light efflorescence deposits in new deck soffit. Widening, honeycombing, light stains, & leakage to longitudinal construction in deck soffit. Very severe spalling/disintegration with medium corrosion to exposed reinforcement to deck/curb fascia at NW corner. Medium spalling & wide transverse cracks in curb surfaces. Light/medium scour/erosion under frame legs/wingwalls. Medium/severe slope erosion at 4 corners of structure. Concrete handrails cracked & post missing at NW end of concrete handrails (opening covered with 2x4's & delineators). Wide horizontal/vertical cracks with medium/severe spalling to remaining concrete handrails. Some rip-rap at D/S end of structure migrating into river.

Overall Condition:	P1 - Poor	Requires Further Inspection:	No
Additional Observations:	P1: Original frame legs, extension deck, fascia, & handrails. F1: Remainder

Next Rehab. Date:	2018	Replacement Year:	2021
Antic. Rehab. Cost:	\$0	Replacement Cost:	\$600000
Recommendations:	Rehab structure. In the interim repair concrete handrails on North side. Possibly place jersey barriers along the Northside.
