GOVERNMENT OF NEWFOUNDLAND AND LABRADOR Department of Transportation and Infrastructure	BRIDGE INSPECTION REPORT B09202021-4	
Date: 4/7/2021	Inspected By: Paul Lawrence	Category: Eng. - Engineering	
BRIDGE INFORMATION			
Site:	1-195 - BROWNSDALE RIVER BRIDGE #1		
Route:		Overall Length:	4.5 m
Year Built:	1960	Est: No	Overall Width: 10.1 m
Year Last Rehab.:		Est: No	Roadway Width: 7.3 m
Region:	AVALON PENINSULA	Sidewalk Width:	0 m
Jurisdiction:	Provincial	Clearance to R.D. or N.W.L.:	1.1 m
Type of Structure:	04 - Rigid Frame	Max Depth of N.W.L.:	0.3 m
Purpose of Structure:	04 - Over Non-Navigable Waters	Spans:	
Type of Handrail:	02 - Concrete Rail	Span No.:	Length
Roadway Surface:	02 - Asphalt	1	3.6
Alignment Vertical:	01 - Good	2	0
Alignment Horizontal:	01 - Good	3	0
Restrictions:	No	6	0
BRIDGE PHOTOS

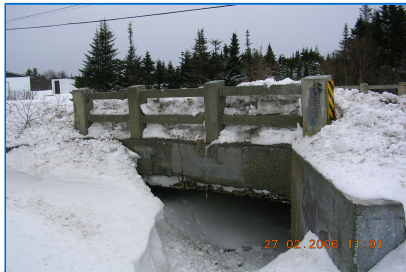
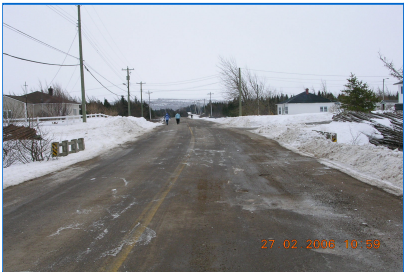
Comments:	Frame legs have been poured onto bedrock Original structure was extended approx. 4.0 m D/S		
SUPERSTRUCTURE			
Condition:	P1 - Poor	Expansion Joints:	I - Inapplicable
Comments:	P1 - original F2 - expansion Severe erosion and scouring along base of both frame legs Frame legs and 4 wingwalls have widening vertical cracks in concrete with efflor. deposits coming through cracks One wingwall tipped towards stream		
DECK			
Condition:	F1 - Fair	Curbs:	I - Inapplicable

Hand Rail:	F1 - Fair	Roadway Condition:	I - Inapplicable
Approach Rail:	I - Inapplicable		
Comments:	- Ext. deck soffit has severe concrete spalling with pieces missing and rebar exposed and rusting - Concrete rails have cracking with some pieces missing exposing rebar. Also rail is too low

Water Velocity:	0.3 m/s	Ice Problem:	P - Possible Problem
Water Depth:	0.3 m	Scour Problem:	K - Known Problem
Waterway:	01 - Adequate	Debris Problem:	N - No Problem
Comments:	Medium to major erosion and scouring under frame legs and wing walls

Overall Condition:	P1 - Poor	Requires Further Inspection:	Yes
Additional Observations:	Should be inspected again as the scouring and concrete deterioration has gotten worse since last inspection
