GOVERNMENT OF NEWFOUNDLAND AND LABRADOR Department of Transportation and Infrastructure	BRIDGE INSPECTION REPORT B06142018-5	
Date: 3/21/2018	Inspected By: Chris Lyver	Category: Eng. - Engineering	
BRIDGE INFORMATION			
Site:	1-252 - BRYANT'S COVE BRIDGE		
Route:	70-20	Overall Length:	10.3 m
Year Built:	2000	Est: Yes	Overall Width: 11.1 m
Year Last Rehab.:		Est: No	Roadway Width: 7.5 m
Region:	AVALON PENINSULA	Sidewalk Width:	0.6 m
Jurisdiction:	Provincial	Clearance to R.D. or N.W.L.:	1 m
Type of Structure:	03 - Reinforced Concrete Beam/Slab	Max Depth of N.W.L.:	0.6 m
Purpose of Structure:	04 - Over Non-Navigable Waters	Spans:	
Type of Handrail:	04 - Steel Rail	<u>Span No.:</u>	<u>Length</u>
Roadway Surface:	02 - Asphalt	1	5
Alignment Vertical:	02 - Adequate	2	0
Alignment Horizontal:	01 - Good	3	0
Restrictions:	No	6	0
BRIDGE PHOTOS

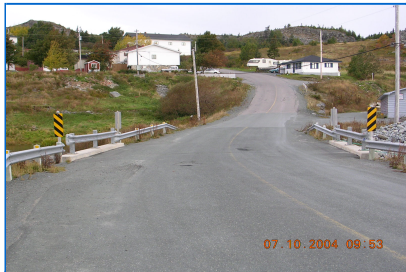
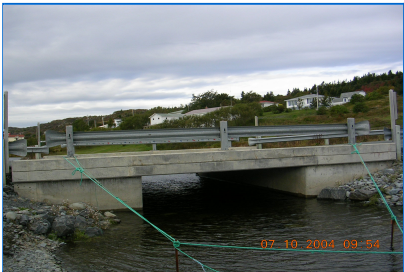
Comments: - Handrail, P (west), F2 (east). - Narrow long. cracks with light efflor./ stalactite deposits in deck soffit. - Narrow vert. cracks in exterior deck/ curb fascia. - Narrow trans./ vert. cracks in curb surfaces and interior fascia. - App./ exit guiderail continues to age with medium scrapes, dents, damage and decaying posts. Light spall to curb/ deck soffit above SW wingwall. - Center post on west guiderail/ handrail struck and cracked off. - Medium asphalt/ shoulder/ slope erosion at 4 corners of structure. - Wide transv. cracks with medium sized potholes and long. cracks in asphalt on deck and approaches.

Overall Condition:	P - Poor	Requires Further Inspection:	No
Additional Observations:	- P (west handrail/ guiderail), - P3 (surface and short sections of approaches). - F2 (remainder). - Unchanged from 2009 and 2011 inspections.

Next Rehab. Date:	2018	Replacement Year:	2075
Antic. Rehab. Cost:	\$25	Replacement Cost:	\$350
Recommendations:	- Repair west guiderail/ handrail ASAP. - Install new app./ exit guiderail as required. - Re-surface deck and approaches. - Correct erosion problem at 4 corners of structure. - Install extra rip-rap as required at 4 corners of structure.
