GOVERNMENT OF NEWFOUNDLAND AND LABRADOR Department of Transportation and Infrastructure	<b>BRIDGE INSPECTION REPORT</b> <b>B06302021-2</b>	
<b>Date:</b> 1/30/2020	<b>Inspected By:</b> Hunt R	<b>Category:</b> Eng. - Engineering	
<b>BRIDGE INFORMATION</b>			
<b>Site:</b>	1-032 - CALVERT RIVER BRIDGE		
<b>Route:</b>		<b>Overall Length:</b>	32.2 m
<b>Year Built:</b>	1994	<b>Est:</b> No	<b>Overall Width:</b> 9.9 m
<b>Year Last Rehab.:</b>		<b>Est:</b> No	<b>Roadway Width:</b> 7.4 m
<b>Region:</b>	AVALON PENINSULA	<b>Sidewalk Width:</b>	0 m
<b>Jurisdiction:</b>	Provincial	<b>Clearance to R.D. or N.W.L.:</b>	0 m
<b>Type of Structure:</b>	01 - AASH to Girder	<b>Max Depth of N.W.L.:</b>	0 m
<b>Purpose of Structure:</b>	03 - Over Navigable Waters	<b>Spans:</b>	
<b>Type of Handrail:</b>	01 - Aluminum Rail	<u>Span No.:</u>	<u>Length</u>
<b>Roadway Surface:</b>	02 - Asphalt	1	22.6
<b>Alignment Vertical:</b>	01 - Good	2	0

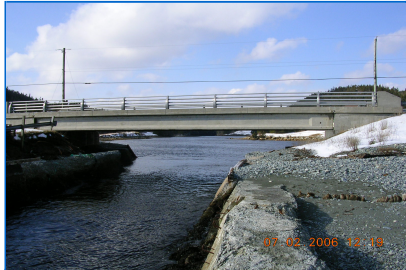
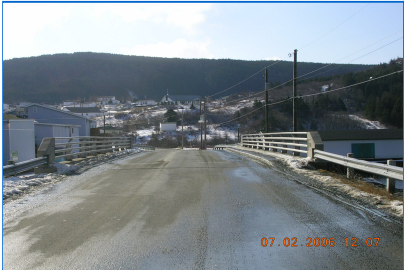
<b>SUBSTRUCTURE</b>			
<b>Condition:</b>	F2 - Fair	<b>Bearings:</b>	F2 - Fair
		<b>Bearing Seat:</b>	P1 - Poor
<b>Comments:</b>	- Assumed condition of buried reinforced concrete abutment footings.-Abutments covered in graffiti. - Light bulging in some bearing pads.		
<b>SUPERSTRUCTURE</b>			
<b>Condition:</b>	P3 - Poor	<b>Expansion Joints:</b>	F2 - Fair
<b>Comments:</b>	P3 - Center Girder, F1 Girders 3 and 5. F2 Remaining Girders. - Medium/ severe delamin./ spalling/ disintegration with medium/ severe rusting to exposed reinf. on bottom flange of center girder. Medium delamination/spalling with medium corrosion to exposed reinforcement to bottom flanges on girders 3 and 5. Light delamination/spalling with light rusting to exposed reinforcement on remaining girders. Some caulking missing from expansion joint gaps on deck curb fascias.

<b>Condition:</b>	F2 - Fair	<b>Curbs:</b>	F2 - Fair
<b>Hand Rail:</b>	F2 - Fair	<b>Roadway Condition:</b>	F2 - Fair
<b>Approach Rail:</b>	P1 - Poor		
<b>Comments:</b>	- Approach rail, P1 (SE buried end rail), F2 (remainder). - Narrow vert. cracks in deck/ curb/ sidewalk fascia. - No hazard markers. - Light/ moderate road settlement at approach slab edges. Medium transverse cracks in asphalt along approach slab faces. Crack in SE rock embedded gutter. Damage to SE buried end guiderail (approach).

<b>Overall Condition:</b>	P1 - Poor	<b>Requires Further Inspection:</b>	No
<b>Additional Observations:</b>	P3 - Center girder. F1 Interior girders. F2 Remainder. P1 SE Guiderail. Remaining observations unchanged from previous inspections.

<b>Next Rehab. Date:</b>	2030	<b>Replacement Year:</b>	2044
<b>Antic. Rehab. Cost:</b>	\$100000	<b>Replacement Cost:</b>	\$1400000
<b>Recommendations:</b>	Repair concrete defects in girders. Caulk expansion joint gaps and control joints. Repair SE guiderail and install regulation hazard markers. Possible erosion on SW corner of structure. Possible erosion on SW corner of structure.
