GOVERNMENT OF NEWFOUNDLAND AND LABRADOR Department of Transportation and Infrastructure	BRIDGE INSPECTION REPORT B06302021-4	
Date: 1/29/2020	Inspected By: Hunt R	Category: Eng. - Engineering	
BRIDGE INFORMATION			
Site:	1-150 - CAPE BROYLE BRIDGE		
Route:		Overall Length:	33.68 m
Year Built:	1997	Est: No	Overall Width: 9.6 m
Year Last Rehab.:		Est: No	Roadway Width: 8.8 m
Region:	AVALON PENINSULA	Sidewalk Width:	1 m
Jurisdiction:	Provincial	Clearance to R.D. or N.W.L.:	4 m
Type of Structure:	04 - Rigid Frame	Max Depth of N.W.L.:	0 m
Purpose of Structure:	04 - Over Non-Navigable Waters	Spans:	
Type of Handrail:	05 - Concrete Barrier	<u>Span No.:</u>	<u>Length</u>
Roadway Surface:	02 - Asphalt	<u>Span No.:</u>	<u>Length</u>
Alignment Vertical:	01 - Good	1	19.6
Alignment Horizontal:	01 - Good	2	0
Restrictions:	No	3	0
		4	0
		5	0
		6	0
BRIDGE PHOTOS

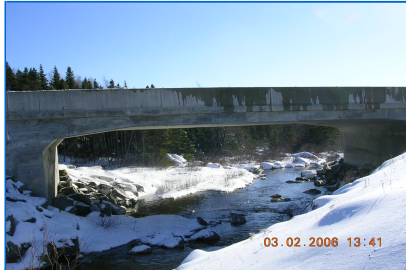
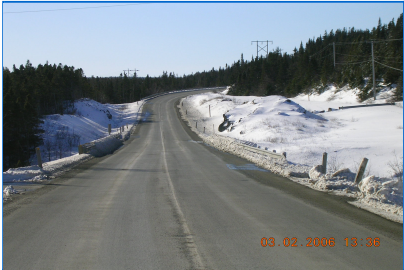
Bearing Seat:	I - Inapplicable
Comments:	Assumed condition of buried reinforced concrete frame leg footings and approach slabs		
SUPERSTRUCTURE			
Condition:	F2 - Fair	Expansion Joints:	I - Inapplicable
Comments:	Some narrow vertical in faces of both frame legs extending up vertically into leg haunches. Narrow vertical cracks with light efflorescence deposits in exterior faces of fame lags. Hairline alligator cracks in all four wingwalls.		
DECK			
Condition:	G - Good	Curbs:	I - Inapplicable
Hand Rail:	F2 - Fair	Roadway Condition:	I - Inapplicable

Approach Rail:	F2 - Fair		
Comments:	Some medium rutting and small potholes in asphalt deck and approaches. Some hazard markers missing. Narrow vertical and hairline alligator cracks in concrete barrier walls. Medium scrapes and dents in approach and exit rail. Erosion continues under rock embedded concrete gutter.		
HYDROLOGY			
Water Velocity:	0.2 m/s	Ice Problem:	N - No Problem
Water Depth:	0.3 m	Scour Problem:	N - No Problem
Waterway:	01 - Adequate	Debris Problem:	N - No Problem
Comments:	Due to snow conditions unable to see sides and shoulder. Assuming the same as previous inspection in 2018.		
REPLACEMENT/REHABILITATION			
Next Rehab. Date:	2023	Replacement Year:	2047
Antic. Rehab. Cost:	\$30000	Replacement Cost:	\$800000
Recommendations:	Install missing hazard markers. Repair asphalt on decks and approaches. Fix erosion on gutters		
OBSERVATIONS			
Overall Condition:	F2 - Fair	Requires Further Inspection:	No
