GOVERNMENT OF NEWFOUNDLAND AND LABRADOR Department of Transportation and Infrastructure	BRIDGE INSPECTION REPORT B11192021-3	
Date: 10/22/2021	Inspected By: Mike Button	Category: Office - Bridge Office	
BRIDGE INFORMATION			
Site:	1-162 - CATARACTS RIVER BRIDGE (ELLIS MEMRL)		
Route:	91	Overall Length:	31.5 m
Year Built:	1926	Est: No	Overall Width: 5.4 m
Year Last Rehab.:	1980	Est: No	Roadway Width: 4.7 m
Region:	AVALON PENINSULA		Sidewalk Width: 0.35 m
Jurisdiction:	Provincial		Clearance to R.D. or N.W.L.: 15.5 m
Type of Structure:	13 - Other		Max Depth of N.W.L.: 0.5 m
Purpose of Structure:	04 - Over Non-Navigable Waters		Spans:
Type of Handrail:	01 - Aluminum Rail		<u>Span No.:</u> <u>Length</u> <u>Span No.:</u> <u>Length</u>
Roadway Surface:	01 - Concrete		1 27.3 4 0
Alignment Vertical:	02 - Adequate		2 0 5 0
Alignment Horizontal:	01 - Good		3 0 6 0
Restrictions:	Yes		
Describe Restrictions:	1lane traffic and weight restriction of 15 tonnes.

BRIDGE PHOTOS

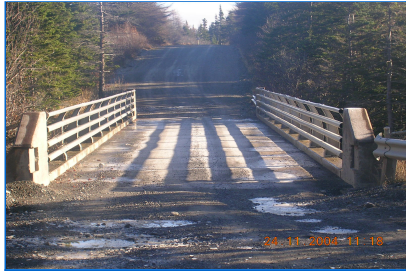
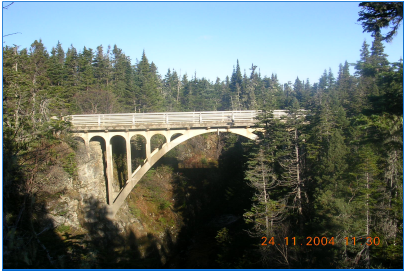
SUBSTRUCTURE			
Condition:	F1 - Fair	Bearings:	I - Inapplicable
		Bearing Seat:	I - Inapplicable
Comments:	- Arch and supporting columns poured onto bedrock. Only access was on the northeast corner below structure and inspection was limited due to extreme hazards. Connections to bedrock look to be in fair condition from a distance.		
SUPERSTRUCTURE			
Condition:	F1 - Fair	Expansion Joints:	F1 - Fair
Comments:	- Only access was on the northeast corner below structure and inspection was limited due to extreme hazards. Main arch and columns appear in fair condition with light cracking.		
DECK			
Condition:	F1 - Fair	Curbs:	F1 - Fair

Hand Rail:	F1 - Fair	Roadway Condition:	F1 - Fair
Approach Rail:	P1 - Poor		
Comments:	- Moderate gravel accumulation and vegetation growth against structure curb causing ponding water atop the concrete deck. - No guiderail northeast corner, 1 Jersey barrier on the northwest corner, guiderail on southeast corner old with broken posts and rails missing bolts. 2 jersey barriers on the northeast corner. Structure overgrown with trees on approaches. - Several potholes on both approaches, F1. - Some handrail posts twisted and disconnected from the top rail. Otherwise handrail in fair condition. Deck concrete in fair condition with mild wear. Hazard marker missing on the northeast end block.

Next Rehab. Date:	2022	Replacement Year:	T.B.D.
Antic. Rehab. Cost:	\$15,000	Replacement Cost:	\$0
Recommendations:	- Install guiderail on approaches complete with regulation hazard markers. - Remove gravel from structure to allow drainage and clean out the expansion joints.
