GOVERNMENT OF NEWFOUNDLAND AND LABRADOR Department of Transportation and Infrastructure	BRIDGE INSPECTION REPORT B09102021-8	
Date: 8/26/2021	Inspected By: Mike Button	Category: Office - Bridge Office	
BRIDGE INFORMATION			
Site:	1-128 - CHANCE COVE RIVER BRIDGE,CAPPAHAYDN		
Route:		Overall Length:	20.5 m
Year Built:	1978	Est: No	Overall Width: 10.7 m
Year Last Rehab.:		Est: No	Roadway Width: 10 m
Region:	AVALON PENINSULA	Sidewalk Width:	0 m
Jurisdiction:	Provincial	Clearance to R.D. or N.W.L.:	3 m
Type of Structure:	02 - Double Tee	Max Depth of N.W.L.:	0.5 m
Purpose of Structure:	04 - Over Non-Navigable Waters	Spans:	
Type of Handrail:	01 - Aluminum Rail	Span No.:	Length
Roadway Surface:	02 - Asphalt	1	8.5
Alignment Vertical:	01 - Good	2	0
Alignment Horizontal:	01 - Good	3	0
Restrictions:	No	6	0
BRIDGE PHOTOS

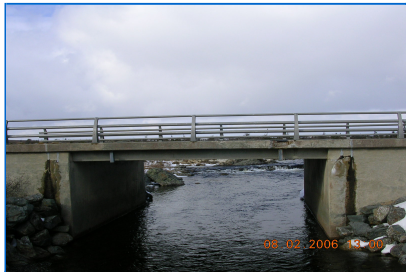
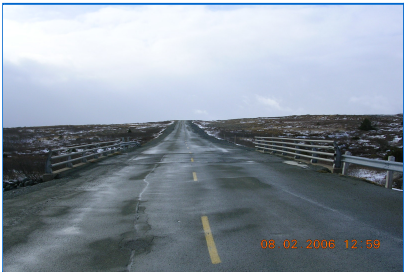
Comments:	- Upstream bearing areas have deterioration to the creep block joints. Attempts have been made to seal it in the past with chaulking but water is still deteriorating the joint, P3. - Other than what was mentioned above, bearings look to be in fair condition but cannot be inspected. Leakage only seen on upstream exterior. - All wingwalls have light-medium cracking with efflorescence. - Both abutments have light erosion/scour to the footing/abutment construction joint. Face in fair condition. Substructure F1.		
SUPERSTRUCTURE			
Condition:	P3 - Poor	Expansion Joints:	U - Uninspectable
Comments:	- Most double tees have stirrups showing on some portion of them due to low/no cover, F1. - Leaking evident with efflorescence between double tee pre-cast panel sections indicative of cracking in the deck above, P3. Mid structure double tee pre-cast panel is showing the rebar mat at mid-span, P3. - Expansion joints have evidences of leaking but not inspect able.

OBSERVATIONS			
Overall Condition:	P3 - Poor	Requires Further Inspection:	No
Additional Observations:	- Leaking between pre-cast panels P3 and exterior upstream bearing areas, F1 remainder. - Deck/curb area currently getting a rehab some scope being debated. - Monitor double tees and deck leakage. - Hazards, steep slopes and traffic.		
LEGEND:			
Condition Definitions:		Problem Definitions:	
1 - *Good - [discontinued code].	F2 - Fair.	C - Unsafe (Closed to Public).	N - No Problem.
2 - *Fair - [discontinued code].	F1 - Fair.	U - Uninspectable.	P - Possible Problem.
3 - *Poor - [discontinued code].	P3 - Poor.	I - Inapplicable.	K - Known Problem.
4 - *Unsafe - [discontinued code].	P1 - Poor.		NA - Not Applicable.
G - Good.	P - Poor.		
PHOTO GUIDELINES:		Category Definitions:	
Inspection Photos:		Maint. - Maintenance.	
Please provide photos using guidelines below:		Eng. - Engineering.	
<ul style="list-style-type: none"> ● Any item which inspector feels should be documented by photograph ● All items noted above as being P3, P1, P, or C ● Any evidence of known ice, scour, debris, waterway problems 		Office - Bridge Office.
