GOVERNMENT OF NEWFOUNDLAND AND LABRADOR Department of Transportation and Infrastructure	BRIDGE INSPECTION REPORT B09142021-9	
Date: 2/25/2020	Inspected By: Chris Lyver	Category: Eng. - Engineering	
BRIDGE INFORMATION			
Site:	1-259 - COOTE'S POND BRIDGE NO.2		
Route:		Overall Length:	17.3 m
Year Built:	1968	Est: No	Overall Width: 11.6 m
Year Last Rehab.:		Est: No	Roadway Width: 8.7 m
Region:	AVALON PENINSULA	Sidewalk Width:	1.5 m
Jurisdiction:	Provincial	Clearance to R.D. or N.W.L.:	1.5 m
Type of Structure:	02 - Double Tee	Max Depth of N.W.L.:	0.4 m
Purpose of Structure:	04 - Over Non-Navigable Waters	Spans:	
Type of Handrail:	02 - Concrete Rail	<u>Span No.:</u>	<u>Length</u>
Roadway Surface:	02 - Asphalt	1	8.7
Alignment Vertical:	01 - Good	2	0
Alignment Horizontal:	01 - Good	3	0
Restrictions:	No	<u>Span No.:</u>	<u>Length</u>
		4	0
		5	0
		6	0
BRIDGE PHOTOS

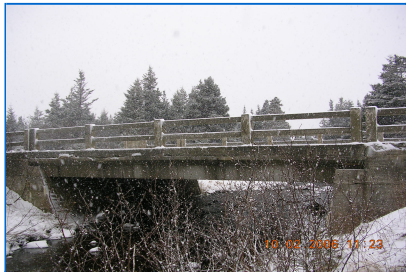
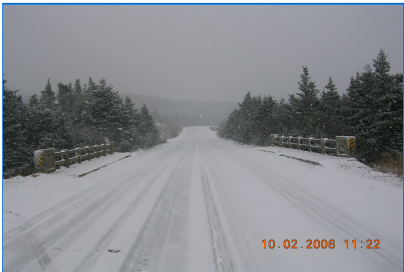
Bearing Seat:	F2 - Fair
Comments:	- Assumed cond. of buried reinf. conc. abut. footings - Narrow vertical cracks in abut. faces - Light/med. delamination/spalling - Medium/severe delamin./spalling to ext. faces of ballast walls under exp. gaps in curbs/sidewalks - Light delamin./honeycombing and narrow vert. cracks in 4 wingwalls		
SUPERSTRUCTURE			
Condition:	F2 - Fair	Expansion Joints:	F2 - Fair
Comments:	- Light delamin./spalling with med. corrosion to exposed reinf. on majority of double tees (insuff. cover) - Med. delamin./spalling with med. corrosion to exp. reinf. along tops of tees under deck drains - No visible signs of exp. joints (possible asphalt impregnated board) - Joints paved over on deck - No chalking in gaps in curbs/sidewalks		
DECK

Condition:	F2 - Fair	Curbs:	P3 - Poor
Hand Rail:	F1 - Fair	Roadway Condition:	P3 - Poor
Approach Rail:	G - Good		
Comments:	- Severe spalling, delamin. and disintegration to areas on curbs/sidewalks and wheelchair ramps - New guiderail/surface asphalt since last inspection - Cold joints in curb/deck fascias opening up - Light spalling/narrow horiz./vert. cracks on conc. handrails

Next Rehab. Date:	2020	Replacement Year:	2030
Antic. Rehab. Cost:	\$75	Replacement Cost:	\$600
Recommendations:	- repair all conc. defects - install regulation haz. markers (maint.)
