GOVERNMENT OF NEWFOUNDLAND AND LABRADOR Department of Transportation and Infrastructure	BRIDGE INSPECTION REPORT B06182021-6	
Date: 1/16/2020	Inspected By: Hunt R	Category: Eng. - Engineering	
BRIDGE INFORMATION			
Site:	1-178 - CROCKER'S BRIDGE, PETTY HARBOUR		
Route:		Overall Length:	30.9 m
Year Built:	1990	Est: No	Overall Width: 9.7 m
Year Last Rehab.:		Est: No	Roadway Width: 7.6 m
Region:	AVALON PENINSULA	Sidewalk Width:	0 m
Jurisdiction:	Provincial	Clearance to R.D. or N.W.L.:	2.5 m
Type of Structure:	04 - Rigid Frame	Max Depth of N.W.L.:	0 m
Purpose of Structure:	04 - Over Non-Navigable Waters	Spans:	
Type of Handrail:	01 - Aluminum Rail	<u>Span No.:</u>	<u>Length</u>
Roadway Surface:	02 - Asphalt	1	15
Alignment Vertical:	01 - Good	2	0
Alignment Horizontal:	02 - Adequate	3	0
Restrictions:	No	<u>Span No.:</u>	<u>Length</u>
		4	0
		5	0
		6	0
BRIDGE PHOTOS

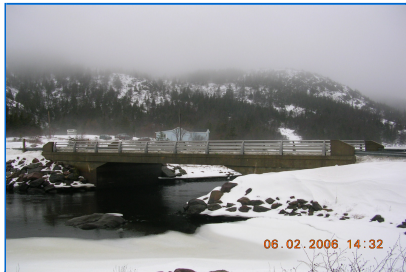
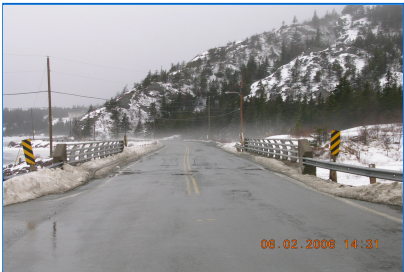
Bearing Seat:	I - Inapplicable
Comments:	- Assumed condition of submerged/ buried concrete frame leg footings.		
SUPERSTRUCTURE			
Condition:	F2 - Fair	Expansion Joints:	I - Inapplicable
Comments:	- Narrow vertical cracks with light efflor. deposits in faces of frame legs, cracks extend upwards across leg haunch and into deck soffit.- Light and Medium efflor. deposits around vertical construction joints between exterior abutment faces and wingwalls. - Hairline alligator cracks in wingwalls, headwalls, and end blocks.		
DECK			
Condition:	G - Good	Curbs:	F2 - Fair

Hand Rail:	F2 - Fair	Roadway Condition:	F2 - Fair
Approach Rail:	F2 - Fair		
Comments:	- Narrow long. cracks with light efflor. deposits to deck soffit. - Narrow horiz./ vert. cracks to deck curbs and fascia. - Medium scrapes, dents and end caps missing in aluminum handrail. - Wide trans. cracks in asphalt at approach slab ends on west side. - Approach and exit rail aging with light/ medium damage, tipping, decaying posts and too close to pavement.

Water Velocity:	0 m/s	Ice Problem:	N - No Problem
Water Depth:	1.5 m	Scour Problem:	N - No Problem
Waterway:	01 - Adequate	Debris Problem:	N - No Problem
Comments:	- Medium slope and shoulder erosion at ends of structure.

Next Rehab. Date:	2022	Replacement Year:	2040
Antic. Rehab. Cost:	\$15000	Replacement Cost:	\$800000
Recommendations:	-Repair Damaged guiderail and fix asphalt issues -Correct shoulder/slope erosion at 4 ends of structure.
