GOVERNMENT OF NEWFOUNDLAND AND LABRADOR Department of Transportation and Infrastructure	BRIDGE INSPECTION REPORT B10272015-6	
Date: 10/25/2015	Inspected By: Rodger Hussey	Category: Eng. - Engineering	
BRIDGE INFORMATION			
Site:	TCH-195 - DONOVANS OVERPASS WEST		
Route:	1	Overall Length:	55.1 m
Year Built:	1998	Est: No	Overall Width: 17.7 m
Year Last Rehab.:		Est: No	Roadway Width: 16.8 m
Region:	AVALON PENINSULA	Sidewalk Width:	0 m
Jurisdiction:	Provincial	Clearance to R.D. or N.W.L.:	5.1 m
Type of Structure:	05 - Pre-stressed Concrete Slab	Max Depth of N.W.L.:	0 m
Purpose of Structure:	01 - Highway Grade Separation	Spans:	
Type of Handrail:	05 - Concrete Barrier	Span No.:	Length
Roadway Surface:	02 - Asphalt	1	11.6
Alignment Vertical:	01 - Good	2	20.3
Alignment Horizontal:	01 - Good	3	11.6
Restrictions:	No	Span No.:	Length
		4	0
		5	0
		6	0
BRIDGE PHOTOS

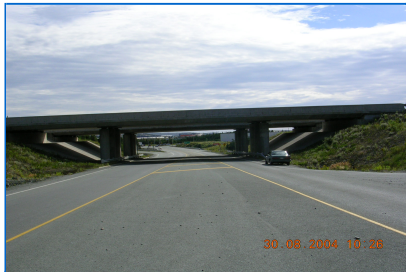
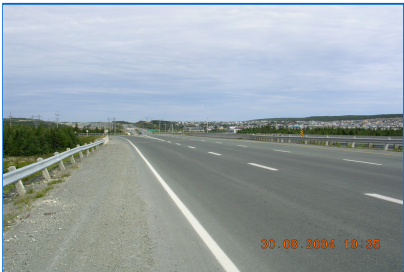
Bearing Seat:	F2 - Fair
Comments:	Moderate vertical cracking extending up the abutment walls, cracks are evenly spaced between bearings, possible moment cracking; Fill adjacent to headwall beginning to erode.		
SUPERSTRUCTURE			
Condition:	G - Good	Expansion Joints:	P3 - Poor
Comments:	Expansion joints damaged, leaking.		
DECK			
Condition:	P3 - Poor	Curbs:	I - Inapplicable
Hand Rail:	F2 - Fair	Roadway Condition:	I - Inapplicable

Approach Rail:	F2 - Fair		
Comments:	Large areas of asphalt stripping, waterproofing membrane compromised; Moderate rutting of driving surface; Minor damage to southeast approach rail; Minor cracking throughout fascia and headwalls; Potholes present near expansion joints.		
HYDROLOGY			
Water Velocity:	0 m/s	Ice Problem:	NA - Not Applicable
Water Depth:	0 m	Scour Problem:	NA - Not Applicable
Waterway:	03 - Not Applicable	Debris Problem:	NA - Not Applicable
Comments:			
REPLACEMENT/REHABILITATION			
Next Rehab. Date:	2015	Replacement Year:	2015
Antic. Rehab. Cost:	\$0	Replacement Cost:	\$0
Recommendations:	Repave driving surface; Replace expansion joints; Install hazard markers.		
OBSERVATIONS			
Overall Condition:	P3 - Poor	Requires Further Inspection:	No
Additional Observations:	Hazard markers missing.		
LEGEND:			
Condition Definitions:		Problem Definitions:	
1 - *Good - [discontinued code].	F2 - Fair.	C - Unsafe (Closed to Public).	N - No Problem.
