GOVERNMENT OF NEWFOUNDLAND AND LABRADOR Department of Transportation and Infrastructure	<b>BRIDGE INSPECTION REPORT</b> <b>B07242018-12</b>	
<b>Date:</b> 5/7/2018	<b>Inspected By:</b> Chris Lyver	<b>Category:</b> Eng. - Engineering	
<b>BRIDGE INFORMATION</b>			
<b>Site:</b>	1-330 - EASON'S ROAD BRIDGE		
<b>Route:</b>	60	<b>Overall Length:</b>	43.1 m
<b>Year Built:</b>	1997	<b>Est: No</b>	<b>Overall Width:</b> 6.05 m
<b>Year Last Rehab.:</b>		<b>Est: No</b>	<b>Roadway Width:</b> 4.1 m
<b>Region:</b>	AVALON PENINSULA	<b>Sidewalk Width:</b>	0 m
<b>Jurisdiction:</b>	Provincial	<b>Clearance to R.D. or N.W.L.:</b>	6.8 m
<b>Type of Structure:</b>	08 - Steel Bridge	<b>Max Depth of N.W.L.:</b>	0 m
<b>Purpose of Structure:</b>	01 - Highway Grade Separation	<b>Spans:</b>	
<b>Type of Handrail:</b>	06 - None	<u>Span No.:</u>	<u>Length</u>
<b>Roadway Surface:</b>	03 - Timber	1	36.5
<b>Alignment Vertical:</b>	01 - Good	2	0

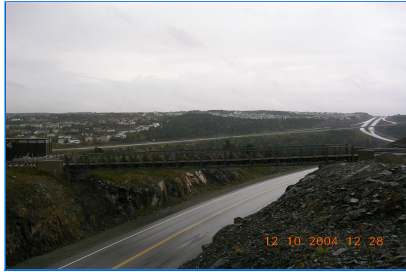
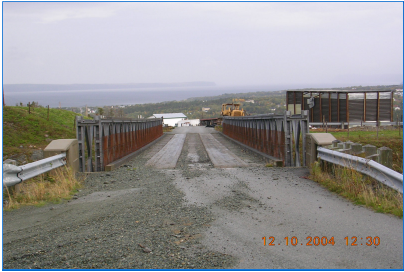
<b>SUBSTRUCTURE</b>			
<b>Condition:</b>	F2 - Fair	<b>Bearings:</b>	F2 - Fair
		<b>Bearing Seat:</b>	F2 - Fair
<b>Comments:</b>	- Double/single compact maybe 200 panel bridge. - Narrow vert. cracks with light efflor. deposits in faces of footings, abutments and ballast walls. - Medium rusting to some connecting bolts on steel bearing base plates. Graffiti on north abutment face.		
<b>SUPERSTRUCTURE</b>			
<b>Condition:</b>	F2 - Fair	<b>Expansion Joints:</b>	I - Inapplicable
<b>Comments:</b>	- Light sag in panels. - Hairline alligator cracks in wingwalls and end blocks. - Medium rusting to steel safety screens attached to panels/ curbs. Rusting continues to stain panels to which screens are attached.		
<b>DECK</b>

<b>Hand Rail:</b>	I - Inapplicable	<b>Roadway Condition:</b>	F2 - Fair
<b>Approach Rail:</b>	P3 - Poor		
<b>Comments:</b>	- Still no hazard markers. - P.T. raceway splitting and wearing. - Medium rusting to majority of end shoe bolts (some still missing). - Fair amount of gravel and vegetation along interior curb faces. - SE buried end app. guiderail no longer attached to horiz. section. - Some guiderail posts splitting with twisted off set blocks. - Short sections of approaches paved. Start of asphalt at north approach cracked off with moderate drop-off. North paved approach is longer than south paved approach.

<b>Overall Condition:</b>	P3 - Poor	<b>Requires Further Inspection:</b>	No
<b>Additional Observations:</b>	- P3 (SE app. guiderail). - F2 (remainder). - Unchanged from 2011 inspection except add: - Storage shed/barn at NE corner of structure.

<b>Next Rehab. Date:</b>	2027	<b>Replacement Year:</b>	2047
<b>Antic. Rehab. Cost:</b>	\$50	<b>Replacement Cost:</b>	\$350
<b>Recommendations:</b>	- Install hazard markers (maint). - Repair/ replace damaged guiderail (maint). - Repair asphalt at north approach. - Replace split areas on raceway. - Paint over graffiti on north abutment (maint)?
