GOVERNMENT OF NEWFOUNDLAND AND LABRADOR Department of Transportation and Infrastructure	BRIDGE INSPECTION REPORT B06062019-1	
Date: 6/6/2019	Inspected By: Pickett R	Category: Eng. - Engineering	
BRIDGE INFORMATION			
Site:	1-263 - FERRY TERMINAL BRIDGE		
Route:		Overall Length:	13.4 m
Year Built:	1960	Est: Yes	Overall Width: 13.5 m
Year Last Rehab.:		Est: No	Roadway Width: 12.3 m
Region:	AVALON PENINSULA	Sidewalk Width:	0 m
Jurisdiction:	Provincial	Clearance to R.D. or N.W.L.:	3.2 m
Type of Structure:	04 - Rigid Frame	Max Depth of N.W.L.:	0.5 m
Purpose of Structure:	04 - Over Non-Navigable Waters	Spans:	
Type of Handrail:	01 - Aluminum Rail	<u>Span No.:</u>	<u>Length</u>
Roadway Surface:	02 - Asphalt	1	5.5
Alignment Vertical:	02 - Adequate	2	0
Alignment Horizontal:	03 - Poor	3	0
Restrictions:	No	Span No.:	Length
		4	0
		5	0
		6	0
BRIDGE PHOTOS

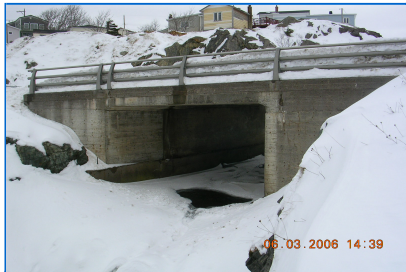
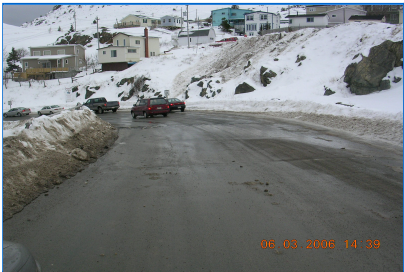
Bearing Seat:	I - Inapplicable
Comments:	Original structure extended approximately 3m downstream. Minor spalding to North East end of original frame.		
SUPERSTRUCTURE			
Condition:	F2 - Fair	Expansion Joints:	I - Inapplicable
Comments:	Wide vertical crack in North East wingwall of intersection with frame leg. Narrow cracks in faces of original frame legs. Alligator minor cracks on all 4 endblocks.		
DECK			
Condition:	F2 - Fair	Curbs:	F2 - Fair
Hand Rail:	F2 - Fair	Roadway Condition:	F2 - Fair

Approach Rail:	F2 - Fair		
Comments:	Narrow cracks in original deck soffit. Narrow cracks in deck/ curb facias. Minor scrapes and dents to aluminum hand rails and guide rails.		
HYDROLOGY			
Water Velocity:	0.7 m/s	Ice Problem:	N - No Problem
Water Depth:	0.5 m	Scour Problem:	P - Possible Problem
Waterway:	01 - Adequate	Debris Problem:	N - No Problem
Comments:	Moderate to severe erosion around all wingwalls. Bulging on retaining wall downstream.		
REPLACEMENT/REHABILITATION			
Next Rehab. Date:	2025	Replacement Year:	2035
Antic. Rehab. Cost:	\$40	Replacement Cost:	\$750
Recommendations:	Repair erosion, monitor gabion retaining wall.		
OBSERVATIONS			
Overall Condition:	F2 - Fair	Requires Further Inspection:	No
Additional Observations:			
LEGEND:			
Condition Definitions:		Problem Definitions:	
1 - *Good - [discontinued code].	F2 - Fair.	C - Unsafe (Closed to Public).	N - No Problem.
2 - *Fair - [discontinued code].	F1 - Fair.	U - Uninspectable.	P - Possible Problem.
