GOVERNMENT OF NEWFOUNDLAND AND LABRADOR Department of Transportation and Infrastructure	BRIDGE INSPECTION REPORT B07242018-5	
Date: 6/22/2018	Inspected By: Chris Lyver	Category: Eng. - Engineering	
BRIDGE INFORMATION			
Site:	1-142 - FOWLER'S ROAD UNDERPASS ON ROUTE 2		
Route:		Overall Length:	62.7 m
Year Built:	1984	Est: No	Overall Width: 11 m
Year Last Rehab.:		Est: No	Roadway Width: 8.2 m
Region:	AVALON PENINSULA	Sidewalk Width:	1.9 m
Jurisdiction:	Provincial	Clearance to R.D. or N.W.L.:	5.4 m
Type of Structure:	05 - Pre-stressed Concrete Slab	Max Depth of N.W.L.:	0 m
Purpose of Structure:	01 - Highway Grade Separation	Spans:	
Type of Handrail:	01 - Aluminum Rail	<u>Span No.:</u>	<u>Length</u>
Roadway Surface:	02 - Asphalt	<u>Span No.:</u>	<u>Length</u>
Alignment Vertical:	01 - Good	1	18.7
Alignment Horizontal:	02 - Adequate	2	0
Restrictions:	No	3	0
		4	0
		5	0
		6	0
BRIDGE PHOTOS

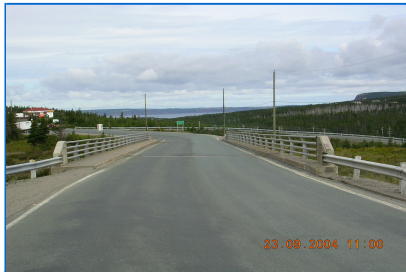
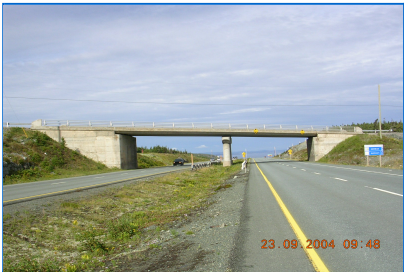
Condition:	F1 - Fair	Bearings:	U - Uninspectable
		Bearing Seat:	U - Uninspectable
Comments:	- Assumed condition of buried reinforced concrete abutments and pier footings. - Assumed condition of bearings and bearing seats (uninspectable due to height). - Numerous areas of narrow/ medium alligator cracking in abutments, wingwalls, pier columns, pier and partially exposed pier footings (A.A.R.) - Light scaling on all pier columns. - Some repair work done to corners of east abutment since last inspection (repair areas have alligator cracking as well).		
SUPERSTRUCTURE			
Condition:	F2 - Fair	Expansion Joints:	G - Good
Comments:	- New expansion joints since last inspection. - Narrow long. cracks in exp joint dams. - Narrow alligator cracking in exterior curbs/ sidewalk fascia at exp. joint locations.		
DECK

Condition:	F2 - Fair	Curbs:	F2 - Fair
Hand Rail:	F2 - Fair	Roadway Condition:	F2 - Fair
Approach Rail:	G - Good		
Comments:	- Numerous alligator, vert and horiz. cracks in 4 end blocks. - Numerous narrow/ medium alligator cracks in deck soffit and fascia (A.A.R). - Interior fascia of curb and sidewalk re-surfaced since last inspection. - Top of SE rock embedded gutter removed since last inspection. - Numerous medium vert./trans./long. cracks in curb/sidewalk tops and exterior fascia. - Light scrapes, dents and end caps missing on aluminum handrails. - New concrete wheelchair ramps on both ends of sidewalk since last inspection. - New rock embedded gutter and small curb gutter at NE end of structure since last inspection. - Deck and approaches resurfaced since last inspection. - New approach and exit guiderail c/w hazard markers since last inspection.

Overall Condition:	F2 - Fair	Requires Further Inspection:	No
Additional Observations:	- F1 (substructure and deck soffit), F2 (remainder). - Unchanged from 2011 inspection, add, new town of CBS sign at SE end of structure on Rte. 2.

Next Rehab. Date:	2025	Replacement Year:	2035
Antic. Rehab. Cost:	\$50	Replacement Cost:	\$1000
Recommendations:	- Clean out expansion joint seals (maint). - Monitor cracking in substructure and superstructure.
