GOVERNMENT OF NEWFOUNDLAND AND LABRADOR Department of Transportation and Infrastructure	BRIDGE INSPECTION REPORT B11052015-11	
Date: 9/23/2015	Inspected By: Rodger Hussey	Category: Eng. - Engineering	
BRIDGE INFORMATION			
Site:	TCH-107 - FOXTRAP ACCESS ROAD OVERPASS EAST		
Route:	1	Overall Length:	41.7 m
Year Built:	1986	Est: No	Overall Width: 14.4 m
Year Last Rehab.:		Est: No	Roadway Width: 12.9 m
Region:	AVALON PENINSULA	Sidewalk Width:	0.75 m
Jurisdiction:	Provincial	Clearance to R.D. or N.W.L.:	5.3 m
Type of Structure:	01 - AASH to Girder	Max Depth of N.W.L.:	0 m
Purpose of Structure:	01 - Highway Grade Separation	Spans:	
Type of Handrail:	01 - Aluminum Rail	<u>Span No.:</u>	<u>Length</u>
Roadway Surface:	02 - Asphalt	1	29.9
Alignment Vertical:	01 - Good	2	0
Alignment Horizontal:	01 - Good	3	0
Restrictions:	No	6	0
BRIDGE PHOTOS

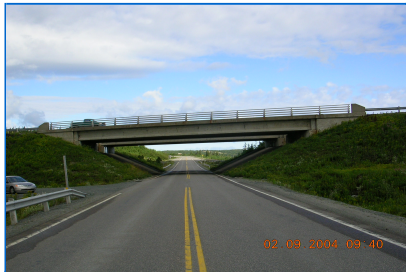
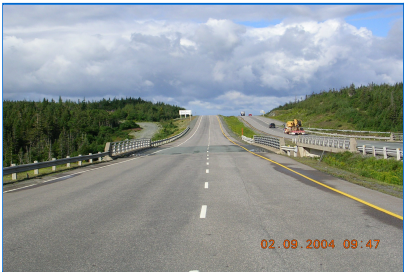
Comments:	Minor/moderate cracking throughout abutment walls, headwalls, end blocks, and creep blocks; Section of moderate spalling at the top of one abutment wall.		
SUPERSTRUCTURE			
Condition:	P3 - Poor	Expansion Joints:	P3 - Poor
Comments:	Honeycombing, delamination, and spalling along the bottom of several girders near bearing seat. Expansion joints leaking.		
DECK			
Condition:	P3 - Poor	Curbs:	F2 - Fair

Hand Rail:	F2 - Fair	Roadway Condition:	F2 - Fair
Approach Rail:	P3 - Poor		
Comments:	One section of approach rail damaged by snow equipment; Rough driving surface, large areas of asphalt patching; Minor spalling along soffit, minor corrosion to exposed reinforcement.		
HYDROLOGY			
Water Velocity:	0 m/s	Ice Problem:	NA - Not Applicable
Water Depth:	0 m	Scour Problem:	NA - Not Applicable
Waterway:	03 - Not Applicable	Debris Problem:	NA - Not Applicable
Comments:			
REPLACEMENT/REHABILITATION			
Next Rehab. Date:	2015	Replacement Year:	2015
Antic. Rehab. Cost:	\$0	Replacement Cost:	\$0
Recommendations:	Replace expansion joints; Repave driving surface; Repair damaged approach rail; Repair girder ends; Repair abutment spalling; Repair soffit; Install hazard marker (1).		
OBSERVATIONS			
Overall Condition:	P3 - Poor	Requires Further Inspection:	No
Additional Observations:	Hazard sign missing (1).		
LEGEND:
