GOVERNMENT OF NEWFOUNDLAND AND LABRADOR Department of Transportation and Infrastructure	<b>BRIDGE INSPECTION REPORT</b> <b>B08102021-6</b>	
<b>Date:</b> 3/10/2020	<b>Inspected By:</b> Gillis M	<b>Category:</b> Eng. - Engineering	
<b>BRIDGE INFORMATION</b>			
<b>Site:</b>	1-070 - GOOSEBERRY COVE BRIDGE		
<b>Route:</b>		<b>Overall Length:</b>	6.8 m
<b>Year Built:</b>	1971	<b>Est: Yes</b>	<b>Overall Width:</b> 11.9 m
<b>Year Last Rehab.:</b>		<b>Est: No</b>	<b>Roadway Width:</b> 11 m
<b>Region:</b>	AVALON PENINSULA	<b>Sidewalk Width:</b>	0 m
<b>Jurisdiction:</b>	Provincial	<b>Clearance to R.D. or N.W.L.:</b>	4.3 m
<b>Type of Structure:</b>	04 - Rigid Frame	<b>Max Depth of N.W.L.:</b>	1 m
<b>Purpose of Structure:</b>	04 - Over Non-Navigable Waters	<b>Spans:</b>	
<b>Type of Handrail:</b>	01 - Aluminum Rail	<u>Span No.:</u>	<u>Length</u>
<b>Roadway Surface:</b>	02 - Asphalt	1	6.2
<b>Alignment Vertical:</b>	02 - Adequate	2	0

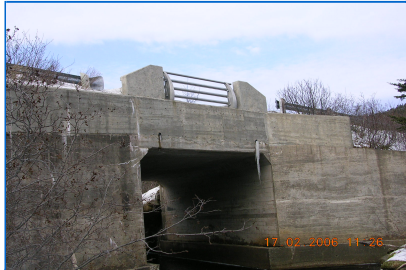
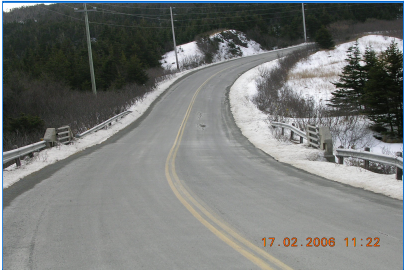
<b>SUBSTRUCTURE</b>			
<b>Condition:</b>	F2 - Fair	<b>Bearings:</b>	I - Inapplicable
		<b>Bearing Seat:</b>	I - Inapplicable
<b>Comments:</b>	- Some medium spalling to top corners of frame leg footing at southeast, southwest & northwest ends. - Narrow horizontal cracks in flow lines with some light efflorescence in faces of frame leg footings. - Construction joints opening up between tops of footings and bottom of frame legs.		
<b>SUPERSTRUCTURE</b>			
<b>Condition:</b>	F2 - Fair	<b>Expansion Joints:</b>	I - Inapplicable
<b>Comments:</b>	- Narrow vertical/angular cracks with light efflorescence in faces of frame legs and wingwall. - End blocks and deck soffit in fair condition.		
<b>DECK</b>			
<b>Condition:</b>	F2 - Fair	<b>Curbs:</b>	F2 - Fair

<b>Hand Rail:</b>	F2 - Fair	<b>Roadway Condition:</b>	F2 - Fair
<b>Approach Rail:</b>	P - Poor		
<b>Comments:</b>	- No hazard markers. - Some narrow longitudinal cracks with light efflorescence in deck soffit. - Light concrete spalling to upstream edge of deck soffit. - Severe shoulder erosion at northwest and southwest corners, resulting in approach & exit rail post undermining. Rail not attached to end blocks, wooden sticks placed between guiderail and end blocks. - Light scrapes and end caps missing from handrail.

<b>Water Velocity:</b>	0.7 m/s	<b>Ice Problem:</b>	N - No Problem
<b>Water Depth:</b>	0.6 m	<b>Scour Problem:</b>	P - Possible Problem
<b>Waterway:</b>	01 - Adequate	<b>Debris Problem:</b>	N - No Problem
<b>Comments:</b>	- Some slope erosion along face and under southwest wingwall.

<b>Overall Condition:</b>	P - Poor	<b>Requires Further Inspection:</b>	No
<b>Additional Observations:</b>	- P approach/exit rail. - F2 remainder. - Mostly unchanged from 2018 inspection. This is 1-070 (South Structure).

<b>Next Rehab. Date:</b>	2020	<b>Replacement Year:</b>	2040
<b>Antic. Rehab. Cost:</b>	\$30	<b>Replacement Cost:</b>	\$800
<b>Recommendations:</b>	- Correct severe shoulder erosion at northwest & southwest corners of structure. - Install new approach/exit rail, regulation hazard markers and attach rail to end blocks. - Monitor scour problem under upstream end of north frame leg footing
