GOVERNMENT OF NEWFOUNDLAND AND LABRADOR Department of Transportation and Infrastructure	BRIDGE INSPECTION REPORT B09132021-7	
Date: 2/17/2020	Inspected By: Hunt R	Category: Eng. - Engineering	
BRIDGE INFORMATION			
Site:	1-166 - HARCOT POND BRIDGE		
Route:		Overall Length:	22.1 m
Year Built:	1986	Est: No	Overall Width: 10.1 m
Year Last Rehab.:		Est: No	Roadway Width: 8.1 m
Region:	AVALON PENINSULA	Sidewalk Width:	1 m
Jurisdiction:	Provincial	Clearance to R.D. or N.W.L.:	2.2 m
Type of Structure:	04 - Rigid Frame	Max Depth of N.W.L.:	1 m
Purpose of Structure:	04 - Over Non-Navigable Waters	Spans:	
Type of Handrail:	01 - Aluminum Rail	<u>Span No.:</u>	<u>Length</u>
Roadway Surface:	01 - Concrete	<u>Span No.:</u>	<u>Length</u>
Alignment Vertical:	01 - Good	1	14.1
Alignment Horizontal:	02 - Adequate	2	0
Restrictions:	No	3	0
		4	0
		5	0
		6	0
BRIDGE PHOTOS

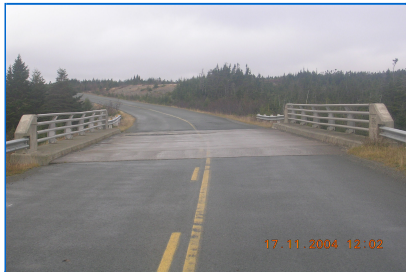
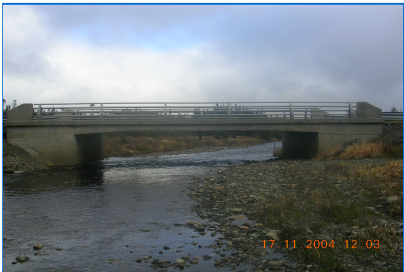
Bearing Seat:	I - Inapplicable
Comments:	- Assumed condition of reinforced concrete frame leg footings. - Some light erosion to abutments near water level. - Narrow horiz./vert. cracks to abutments and wingwall faces. - Medium/wide cracking to abutment faces with medium efflor. deposits.		
SUPERSTRUCTURE			
Condition:	F1 - Fair	Expansion Joints:	I - Inapplicable
Comments:	- Medium transvers cracking throughout deck soffit. - Large cracks at deck curbs and abutment interfaces on all 4 corners		
DECK			
Condition:	P3 - Poor	Curbs:	F1 - Fair

Hand Rail:	F1 - Fair	Roadway Condition:	F1 - Fair
Approach Rail:	P - Poor		
Comments:	- Condition, P3 (surface), F1 (remainder). - Approach rail, P (SW rail), F1 (remainder.) - No hazard markers. - Medium trans. cracks and honeycombing in deck soffit. - Wide horiz./angular cracks with light/medium efflor. deposits in deck fascia. - Narrow cracks in deck soffit at deck drain downspouts. Light spalling on exposed deck surface. - Numerous wide vert./horiz./trans. cracks in deck curbs. - Numerous medium/wide map cracks in deck surface. - SW approach rail damaged and unattached from end block. Remaining rail has dents and scrapes with deteriorating posts. - Potholes in approach asphalt with a lot of water buildup on south side of deck at curbs. - Scrapes, dents, and end caps missing in alum. handrail.

Water Velocity:	0.4 m/s	Ice Problem:	P - Possible Problem
Water Depth:	0.4 m	Scour Problem:	N - No Problem
Waterway:	01 - Adequate	Debris Problem:	P - Possible Problem
Comments:	- Severe asphalt/ shoulder/ slope erosion at NW, SE, and SW ends of structure. - Rip-rap at 4 corners of structure in fair condition.

Overall Condition:	P - Poor	Requires Further Inspection:	No
Additional Observations:	- P (SW approach rail, asphalt/ slope/ shoulder erosion). - P3 (Exposed concrete deck surface). - F1 (remainder).

Next Rehab. Date:	2021	Replacement Year:	2036
Antic. Rehab. Cost:	\$200	Replacement Cost:	\$900
Recommendations:	- Overlay deck and approach slabs. - Resurface curbs, install new guiderail c/w regulation hazard markers. - Fix asphalt/ slope/ shoulder erosion on bad corners of structure.
