GOVERNMENT OF NEWFOUNDLAND AND LABRADOR Department of Transportation and Infrastructure	BRIDGE INSPECTION REPORT B09142021-15	
Date: 9/14/2021	Inspected By: Paul Lawrence	Category: Eng. - Engineering	
BRIDGE INFORMATION			
Site:	1-191 - HINDY'S BROOK BRIDGE, WINTERTON		
Route:		Overall Length:	7.3 m
Year Built:	1960	Est: No	Overall Width: 7.9 m
Year Last Rehab.:		Est: No	Roadway Width: 7.2 m
Region:	AVALON PENINSULA	Sidewalk Width:	0 m
Jurisdiction:	Provincial	Clearance to R.D. or N.W.L.:	2 m
Type of Structure:	04 - Rigid Frame	Max Depth of N.W.L.:	0.3 m
Purpose of Structure:	04 - Over Non-Navigable Waters	Spans:	
Type of Handrail:	02 - Concrete Rail	<u>Span No.:</u>	<u>Length</u>
Roadway Surface:	02 - Asphalt	1	6
Alignment Vertical:	02 - Adequate	2	0
Alignment Horizontal:	02 - Adequate	3	0
Restrictions:	No	<u>Span No.:</u>	<u>Length</u>
		4	0
		5	0
		6	0
BRIDGE PHOTOS

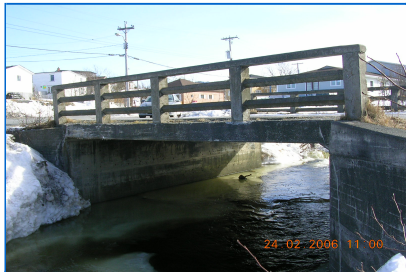
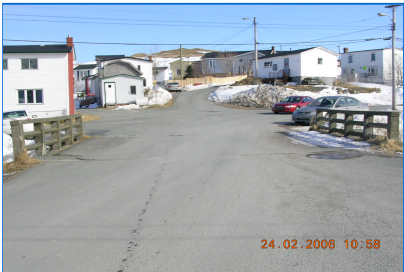
Bearing Seat:	F1 - Fair
Comments:	- Abutments poured on bedrock - Bearing cond. assumed - Cracking medium all through abutments with efflor. deposits coming through, also on wingwalls		
SUPERSTRUCTURE			
Condition:	F1 - Fair	Expansion Joints:	I - Inapplicable
Comments:			
DECK			
Condition:	P - Poor	Curbs:	I - Inapplicable
Hand Rail:	P - Poor	Roadway Condition:	I - Inapplicable

Approach Rail:	I - Inapplicable		
Comments:	- Severe concrete spalling and deterioration on concrete deck edges falling apart with rebar exposed and corroded - Concrete rails cracked and broken - Rebar exposed, asphalt surface rotted with many potholes		
HYDROLOGY			
Water Velocity:	0.3 m/s	Ice Problem:	P - Possible Problem
Water Depth:	0.2 m	Scour Problem:	P - Possible Problem
Waterway:	01 - Adequate	Debris Problem:	N - No Problem
Comments:	- Some hyd. rip-rap slipped into channel		
REPLACEMENT/REHABILITATION			
Next Rehab. Date:	2021	Replacement Year:	2021
Antic. Rehab. Cost:	\$0	Replacement Cost:	\$0
Recommendations:			
OBSERVATIONS			
Overall Condition:	P1 - Poor	Requires Further Inspection:	No
Additional Observations:			
LEGEND:			
Condition Definitions:		Problem Definitions:	
1 - *Good - [discontinued code].	F2 - Fair.	C - Unsafe (Closed to Public).	N - No Problem.
2 - *Fair - [discontinued code].	F1 - Fair.	U - Uninspectable.	P - Possible Problem.
