GOVERNMENT OF NEWFOUNDLAND AND LABRADOR Department of Transportation and Infrastructure	BRIDGE INSPECTION REPORT B09102021-14	
Date: 2/27/2020	Inspected By: Chris Lyver	Category: Eng. - Engineering	
BRIDGE INFORMATION			
Site:	1-170 - HODGE RIVER BRIDGE		
Route:	81	Overall Length:	23 m
Year Built:	1990	Est: No	Overall Width: 10 m
Year Last Rehab.:		Est: No	Roadway Width: 7.7 m
Region:	AVALON PENINSULA	Sidewalk Width:	1.5 m
Jurisdiction:	Provincial	Clearance to R.D. or N.W.L.:	1.7 m
Type of Structure:	04 - Rigid Frame	Max Depth of N.W.L.:	0.5 m
Purpose of Structure:	04 - Over Non-Navigable Waters		
Type of Handrail:	01 - Aluminum Rail	Spans:	
Roadway Surface:	02 - Asphalt	<u>Span No.:</u>	<u>Length</u>
Alignment Vertical:	01 - Good	<u>Span No.:</u>	<u>Length</u>
Alignment Horizontal:	02 - Adequate	<u>Span No.:</u>	<u>Length</u>
Restrictions:	No	1	13
		2	0
		3	0
		4	0
		5	0
		6	0
BRIDGE PHOTOS

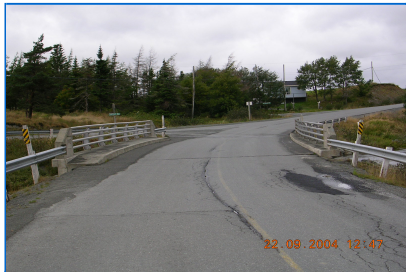
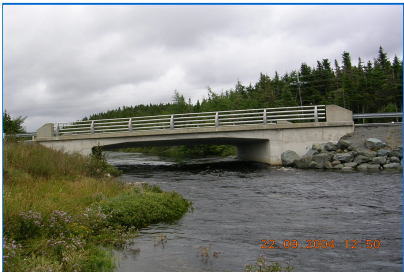
Condition:	F2 - Fair	Bearings:	I - Inapplicable
		Bearing Seat:	I - Inapplicable
Comments:	- Assumed condition of buried/submerged reinf. conc. frame leg footings.		
SUPERSTRUCTURE			
Condition:	F2 - Fair	Expansion Joints:	I - Inapplicable
Comments:	- Narrow vert. cracks in faces of frame legs. - Narrow horiz./vert. cracks in U/S wingwalls. - Extensive narrow/medium alligator cracking in D/S wings (A.A.R)? - Narrow/medium horiz./vert./alligator cracks and impact spalls to endblocks		
DECK			
Condition:	F2 - Fair	Curbs:	F1 - Fair

Hand Rail:	P3 - Poor	Roadway Condition:	F1 - Fair
Approach Rail:	P1 - Poor		
Comments:	- Narrow long. cracks with light efflor. deposits in deck soffit. - Narrow vert./trans. cracks in curb surfaces and interior fascia. - Medium/wide horiz./alligator cracks in exterior curb fascias (A.R.R.) - App./exit guiderail remains in poor condition - Scrapes, dents, endcaps missing on alumn. handrails (impact damage at NE endpost and rails)

Water Velocity:	0.5 m/s	Ice Problem:	N - No Problem
Water Depth:	0.8 m	Scour Problem:	N - No Problem
Waterway:	01 - Adequate	Debris Problem:	N - No Problem
Comments:	- Slope erosion continues along wingwalls - Asphalt and slope erosion continues at NE/SE ends of structure. - Rip-rap at NE corner of structure migrating into channel.

Overall Condition:	P1 - Poor	Requires Further Inspection:	No
Additional Observations:	P1 - app. rail and surface P3 - Handrails F1 - Remainder Unchanged from 2011 inspection

Next Rehab. Date:	2020	Replacement Year:	2040
Antic. Rehab. Cost:	\$100	Replacement Cost:	\$850
Recommendations:	- Repair all concrete defects - Re-surface deck and approaches - Repair alumn. handrails - Install new app./exit guiderail c/s regulation haz. markers - Repair asphalt/slope erosion and place additional rip-rap at NE end of structure
