GOVERNMENT OF NEWFOUNDLAND AND LABRADOR Department of Transportation and Infrastructure	<b>BRIDGE INSPECTION REPORT</b> <b>B09212021-4</b>	
<b>Date:</b> 2/15/2019	<b>Inspected By:</b> Hunt R	<b>Category:</b> Eng. - Engineering	
<b>BRIDGE INFORMATION</b>			
<b>Site:</b>	1-270 - LEES BROOK BRIDGE		
<b>Route:</b>		<b>Overall Length:</b>	9.4 m
<b>Year Built:</b>	1940	<b>Est:</b> Yes	<b>Overall Width:</b> 11.8 m
<b>Year Last Rehab.:</b>	1965	<b>Est:</b> Yes	<b>Roadway Width:</b> 9.7 m
<b>Region:</b>	AVALON PENINSULA		<b>Sidewalk Width:</b> 0 m
<b>Jurisdiction:</b>	Provincial		<b>Clearance to R.D. or N.W.L.:</b> 2.3 m
<b>Type of Structure:</b>	04 - Rigid Frame		<b>Max Depth of N.W.L.:</b> 0.2 m
<b>Purpose of Structure:</b>	04 - Over Non-Navigable Waters		<b>Spans:</b>
<b>Type of Handrail:</b>	02 - Concrete Rail		<u>Span No.:</u> <u>Length</u> <u>Span No.:</u> <u>Length</u>
<b>Roadway Surface:</b>	02 - Asphalt		1            4.6            4            0

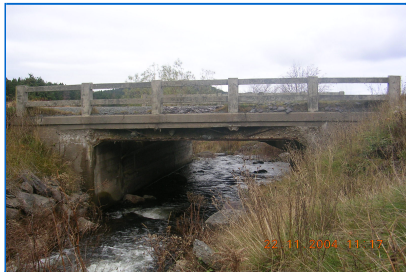
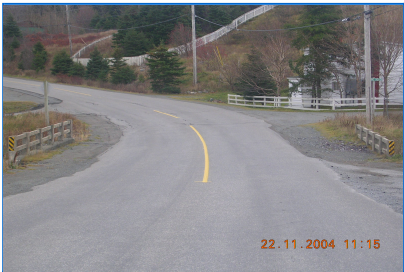
<b>Alignment Vertical:</b>	01 - Good		2            0                5            0
<b>Alignment Horizontal:</b>	02 - Adequate		3            0                6            0
<b>Restrictions:</b>	No		
<b>BRIDGE PHOTOS</b>
