GOVERNMENT OF NEWFOUNDLAND AND LABRADOR Department of Transportation and Infrastructure	BRIDGE INSPECTION REPORT B05292019-1	
Date: 5/29/2019	Inspected By: lyver C	Category: Eng. - Engineering	
BRIDGE INFORMATION			
Site:	1-338 - LEGION ROAD UNDERPASS CBS BYPASS		
Route:		Overall Length:	46.2 m
Year Built:	2001	Est: No	Overall Width: 10 m
Year Last Rehab.:		Est: No	Roadway Width: 4.3 m
Region:	AVALON PENINSULA	Sidewalk Width:	0 m
Jurisdiction:	Provincial	Clearance to R.D. or N.W.L.:	6.3 m
Type of Structure:	04 - Rigid Frame	Max Depth of N.W.L.:	0 m
Purpose of Structure:	01 - Highway Grade Separation	Spans:	
Type of Handrail:	01 - Aluminum Rail	Span No.:	Length
Roadway Surface:	01 - Concrete	1	21.7
Alignment Vertical:	01 - Good	2	0
Alignment Horizontal:	01 - Good	3	0
Restrictions:	No	Span No.:	Length
		4	0
		5	0
		6	0
BRIDGE PHOTOS

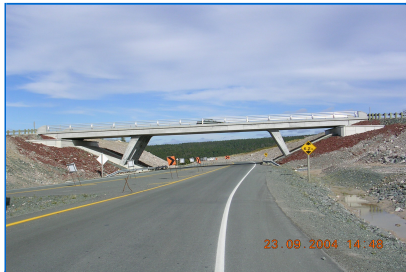
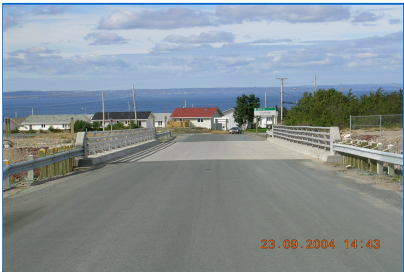
Comments:	Assumed condition of buried reinforcement concrete structure and cantilevered deck retaining wall footings. Cantilevered deck footings remain partially exposed and in good condition. Narrow vertical cracks in some MSE wall panels (majority of panels are under slope paving). Medium transverse cracks in some areas of slope paving's. Hairline transverse/Alligator cracks in some reinforcement concrete structure.		
SUPERSTRUCTURE			
Condition:	F2 - Fair	Expansion Joints:	F2 - Fair
Comments:	Medium abrasion to extension joint dams. Medium corrosion to expansion joint striker plates.		
DECK			
Condition:	F2 - Fair	Curbs:	F2 - Fair

Hand Rail:	F2 - Fair	Roadway Condition:	F2 - Fair
Approach Rail:	F2 - Fair		
Comments:	Light spalling in exposed deck surface center. Hazard marker cracked off at South East end. Medium damage (scape dents) to guiderail on route 60 legion road. Narrow map cracking in asphalt at approach slab edges. Asphalt ramped up at approach slab edges. Medium Asphalt settlement at approach slab edges. Narrow transverse vertical cracks with light efflor deposits in curb facials. Narrow long/transverse cracks in exposed deck surface. Wide cracks in the beginning and end of North East rock embedded gutter.

Overall Condition:	F2 - Fair	Requires Further Inspection:	No
Additional Observations:	Unchanged from 2015 inspection. Double overhead sign attached to east deck fascials.

Next Rehab. Date:	2033	Replacement Year:	2076
Antic. Rehab. Cost:	\$200	Replacement Cost:	\$2500
Recommendations:	Clean out extension joint seals (maintain). Replace South East hazard marker (maintain). Repair damaged guiderail(Maintain). Repair North East damaged rock embedded gutter.
