GOVERNMENT OF NEWFOUNDLAND AND LABRADOR Department of Transportation and Infrastructure	BRIDGE INSPECTION REPORT B09092021-7	
Date: 2/26/2020	Inspected By: Chris Lyver	Category: Eng. - Engineering	
BRIDGE INFORMATION			
Site:	1-134 - LITTLE BARACHOIS RIVER BRIDGE		
Route:	92	Overall Length:	28.2 m
Year Built:	1978	Est: Yes	Overall Width: 9.5 m
Year Last Rehab.:		Est: No	Roadway Width: 8.7 m
Region:	AVALON PENINSULA	Sidewalk Width:	0.4 m
Jurisdiction:	Provincial	Clearance to R.D. or N.W.L.:	5.2 m
Type of Structure:	01 - AASH to Girder	Max Depth of N.W.L.:	0.5 m
Purpose of Structure:	04 - Over Non-Navigable Waters	Spans:	
Type of Handrail:	01 - Aluminum Rail	Span No.:	Length
Roadway Surface:	01 - Concrete	Span No.:	Length
Alignment Vertical:	01 - Good	1	14.4
Alignment Horizontal:	01 - Good	2	0
Restrictions:	No	3	0
		4	0
		5	0
		6	0
BRIDGE PHOTOS

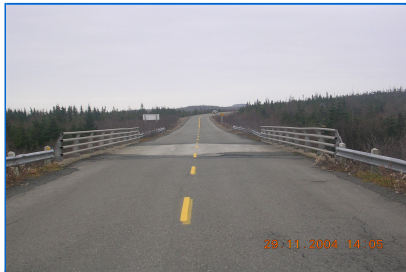
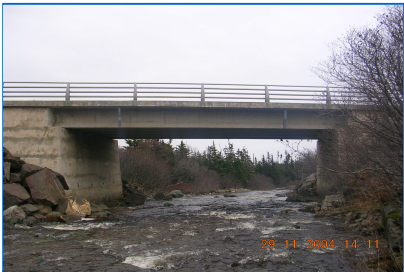
Bearing Seat:	F2 - Fair
Comments:	- Assumed condition of buried/submerged reinf. conc. abut. footings. - Medium/wide horiz./vert. cracks with medium efflor. deposits and light/med delamin./spalling in abutment faces. - Medium horiz./vert cracks with medium delamin./spalling along tops of wings under curbs. - Medium horiz./vert. cracks with medium delamin./spalling to ext. ballast wall faces. - Narrow map cracking with light efflor. deposits in 4 wigwalls (A.A.R.). - Assumed cond. of bearing seats (height restriction)		
SUPERSTRUCTURE			
Condition:	F2 - Fair	Expansion Joints:	F2 - Fair
Comments:	- Light delamin./spalling with medium rusting to exposed reinf. on majority of girders (insuff, cover). - Light horiz./angular cracks in ends of most girders. - Light abrasion and medium longit. cracks in exp. joint dams. - Possible leakage in exp joints (staining on abut faces)

DECK			
Condition:	F1 - Fair	Curbs:	F2 - Fair
Hand Rail:	G - Good	Roadway Condition:	F2 - Fair
Approach Rail:	F2 - Fair		
Comments:	- Medium trans. cracks with light efflor. deposits in deck soffit. (esp. cantilevered sections outside ext. girders) - Medium vert./horiz. cracks with light efflor. deposits in deck fascias. - Numerous areas of light/medium spalls; abrasion on exposed deck surface - Numerous potholes (some patched) along approached on rte. 92 - Assumed cond. of approach rail (currently buried) - Moderate settlement at exp. joint dams		
HYDROLOGY			
Water Velocity:	0.3 m/s	Ice Problem:	N - No Problem
Water Depth:	0.5 m	Scour Problem:	N - No Problem
Waterway:	01 - Adequate	Debris Problem:	N - No Problem
Comments:	- Assume rip-rap at NE, NW, SW corners of structure still migrating into channel (currently buried)		
REPLACEMENT/REHABILITATION			
Next Rehab. Date:	2025	Replacement Year:	2035
Antic. Rehab. Cost:	\$75	Replacement Cost:	\$2500

Recommendations:	- Repair all conc. defects - Assume repair SW exit guiderail (currently buried) - Clean out expansion joint seals (maint.) - Install new rip-rap at NE, NW, SW corners		
OBSERVATIONS			
Overall Condition:	P3 - Poor	Requires Further Inspection:	No
Additional Observations:	- unchanged from 2011/2013 inspections - someexp. joint replacement formwork/styrofoam remains in place		
LEGEND:			
Condition Definitions:		Problem Definitions:	
1 - *Good - [discontinued code].	F2 - Fair.	C - Unsafe (Closed to Public).	N - No Problem.
2 - *Fair - [discontinued code].	F1 - Fair.	U - Uninspectable.	P - Possible Problem.
3 - *Poor - [discontinued code].	P3 - Poor.	I - Inapplicable.	K - Known Problem.
4 - *Unsafe - [discontinued code].	P1 - Poor.		NA - Not Applicable.
G - Good.	P - Poor.		
Category Definitions:			
Mant. - Maintenance.			
Eng. - Engineering.			
Office - Bridge Office.			
PHOTO GUIDELINES:
