GOVERNMENT OF NEWFOUNDLAND AND LABRADOR Department of Transportation and Infrastructure	BRIDGE INSPECTION REPORT B05112015-11	
Date: 2/11/2015	Inspected By: Chris Lyver	Category: Eng. - Engineering	
BRIDGE INFORMATION			
Site:	1-201 - LOWER ISLAND COVE RIVER BRIDGE		
Route:		Overall Length:	9.2 m
Year Built:	1965	Est: No	Overall Width: 10.8 m
Year Last Rehab.:		Est: No	Roadway Width: 6.4 m
Region:	AVALON PENINSULA	Sidewalk Width:	0 m
Jurisdiction:	Provincial	Clearance to R.D. or N.W.L.:	0.9 m
Type of Structure:	04 - Rigid Frame	Max Depth of N.W.L.:	0.3 m
Purpose of Structure:	04 - Over Non-Navigable Waters	Spans:	
Type of Handrail:	02 - Concrete Rail	<u>Span No.:</u>	<u>Length</u>
Roadway Surface:	02 - Asphalt	1	4.7
Alignment Vertical:	01 - Good	2	0
Alignment Horizontal:	02 - Adequate	3	0
Restrictions:	No	6	0
BRIDGE PHOTOS

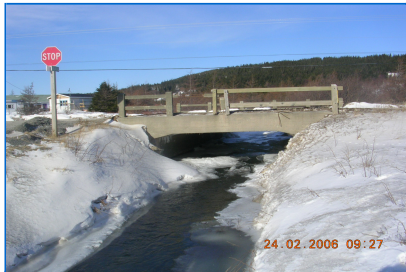
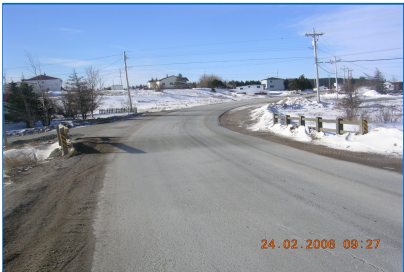
Comments:	- No frame leg footings on original structure legs poured directly onto (rock?) riverbed - Assumed condition of buried/submerged reinf. conc. frame leg footings on extension		
SUPERSTRUCTURE			
Condition:	P - Poor	Expansion Joints:	I - Inapplicable
Comments:	- Very severe scour/erosion continues under orig. frame legs (bott. sections eroded away) deep eroded section at bott. middle of original south frame leg - Numerous wide vert/horiz cracks with light efflor deposits in faces of original frame legs. Narrow alligator cracks in faces of u/s wings - Severe delamin/spalling to SE corner of original south frame leg - Severe delamin/spalling with heavy efflor deposits at const. joints between orig. frame legs and u/s extension		
DECK

Condition:	P3 - Poor	Curbs:	F1 - Fair
Hand Rail:	P - Poor	Roadway Condition:	F1 - Fair
Approach Rail:	I - Inapplicable		
Comments:	- Narrow vert/transv cracks and light spalling in curbs - Numerous longit. medium effior deposits in orig. deck soffit. - Medium spalling with medium effior deposits and light leaking in deck soffit at const. joint between orig. structure and u/s extension - Light delamin/spalling in deck soffit at D/S const. joint - Narrow horz/vert cracks with medium effior deposits in u/s deck fascias - Light honeycombing in deck soffit on u/s extension - Light spalling/scaling to sides of exposed deck surface - Light spalling/abrasion and narrow vert/horz cracks in conc. hand rails

Water Velocity:	0.3 m/s	Ice Problem:	N - No Problem
Water Depth:	0.3 m	Scour Problem:	K - Known Problem
Waterway:	01 - Adequate	Debris Problem:	N - No Problem
Comments:	- NE and SW conc. handrail posts missing. Guiderail at NE end of struct. struck and tipped out (haz markers still attached) no haz markers at SE end of structure - Light potholes and patching on asphalt on deck and approaches

Overall Condition:	P - Poor	Requires Further Inspection:	Yes
Additional Observations:	P: Original frame legs, NE/SW handrail ends F1: Remainder - Unchanged from 2012 inspection, add light erosion under D?S rip-rap at corners of structure

Next Rehab. Date:		Replacement Year:	2015
Antic. Rehab. Cost:	\$0	Replacement Cost:	\$150
Recommendations:	- Replace with alumin./steel box culvert - In the interim, monitor scour under orig. frame legs, repair conc. handrails and install app./exit guiderail (where possible) c/w haz. markers (maint.) * Bridge office should re-inspect bottoms of orig. frame legs
