| | GOVERNMENT OF NEWFOUNDLAND AND LABRADOR Department of Transportation and Infrastructure | BRIDGE INSPECTION REPORT B11052015-13 | |
| Date: 9/23/2015 | Inspected By: Rodger Hussey | Category: Eng. - Engineering | |
| Site: | TCH-105 - MANUEL'S RIVER FEEDER CANAL (WEST) | | |

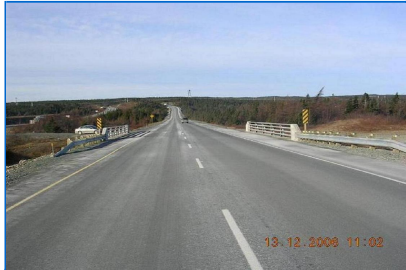
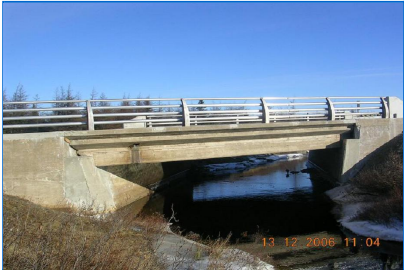
| Comments: | Exterior face of ballast wall/ bearing seat has severe scaling at all four corners, minor corrosion to exposed reinforcement. Minor cracking throughout abutment walls and headwalls. | | |

| Additional Observations: | Hazard marker missing (1). | | |

| Recommendations: | Install hazard marker; Repair scaling on ballast walls/ abutment corners. | | |
