GOVERNMENT OF NEWFOUNDLAND AND LABRADOR Department of Transportation and Infrastructure	BRIDGE INSPECTION REPORT B05232018-25	
Date: 2/6/2018	Inspected By: Chris Lyver	Category: Eng. - Engineering	
BRIDGE INFORMATION			
Site:	1-280 - MUTTON BAY BRIDGE		
Route:		Overall Length:	16.9 m
Year Built:	1967	Est: No	Overall Width: 8.9 m
Year Last Rehab.:		Est: No	Roadway Width: 7.4 m
Region:	AVALON PENINSULA	Sidewalk Width:	0 m
Jurisdiction:	Provincial	Clearance to R.D. or N.W.L.:	2.1 m
Type of Structure:	02 - Double Tee	Max Depth of N.W.L.:	0.5 m
Purpose of Structure:	04 - Over Non-Navigable Waters	Spans:	
Type of Handrail:	02 - Concrete Rail	<u>Span No.:</u>	<u>Length</u>
Roadway Surface:	02 - Asphalt	<u>Span No.:</u>	<u>Length</u>
Alignment Vertical:	01 - Good	1	11.8
Alignment Horizontal:	01 - Good	2	0
Restrictions:	No	3	0
		4	0
		5	0
		6	0
BRIDGE PHOTOS

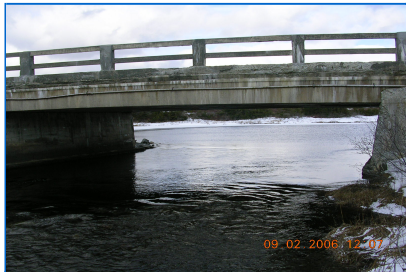
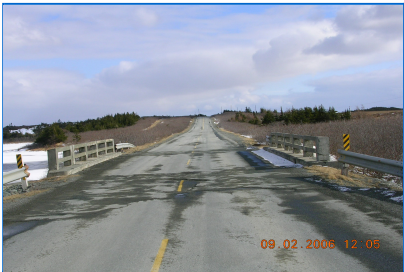
Bearing Seat:	P1 - Poor
Comments:	Wide transverse cracks in tops and faces of abutment footings. Severe erosion/spalling/disintegration to corners of abutment footings. Severe delamination/spalling/disintegration to abutment corners. Numerous medium horizontal/vertical cracks with heavy efflorescence deposits with areas of severe delamination/spalling/disintegration to four wingwalls. No visible signs of bearings (AIB?). Severe spalling/disintegration to d/s exterior bearing seats. Spalling migration towards double tee(AAR). P1 - Dis. Seats F1 - Remainder		
SUPERSTRUCTURE			
Condition:	F1 - Fair	Expansion Joints:	P3 - Poor
Comments:	Very severe delamination/spalling/disintegration to exterior creep blocks. Wide vertical cracks with heavy efflorescence deposits to majority of end diaphragms. Narrow longitudinal/vertical cracks with light/heavy stalactites/efflor. deposits between double tees. Tees in fair condition. Expansion joints paved over on deck.

Water leakage/staining with heavy efflor. deposits on abutment faces (leaking joints?).

Condition:	F1 - Fair	Curbs:	P - Poor
Hand Rail:	P - Poor	Roadway Condition:	P - Poor
Approach Rail:	P1 - Poor		
Comments:	Numerous areas of severe delamination/spalling/disintegration with medium horizontal/vertical cracks in curb surfaces and fascia. Severe disintegration to majority of concrete handrails. Top d/s rail missing. U/S top center rail cracked in two. Asphalt on deck & approaches remains in very poor condition with numerous patched areas. Large pothole with deck exposed at south end of structure. Approach/exit guiderail damaged in places; tipping with decaying posts.

Water Velocity:	0.4 m/s	Ice Problem:	P - Possible Problem
Water Depth:	0.5 m	Scour Problem:	N - No Problem
Waterway:	01 - Adequate	Debris Problem:	P - Possible Problem
Comments:	Medium shoulder/slope erosion at 4 corners of structure. Medium road settlement at structure ends.

Overall Condition:	P1 - Poor	Requires Further Inspection:	Yes
Additional Observations:	Unchanged from previous inspection, except new pole-line running along east (d/s) side of the structure.

Next Rehab. Date:	2018	Replacement Year:	2025
Antic. Rehab. Cost:	\$200000	Replacement Cost:	\$500000
Recommendations:	Structure should be re-inspected by Bridge Office and rehabbed or replaced. In the interim install new guiderail c/w hazard markers (maintenance) and possibly resurface deck/approaches and fix handrails.
