GOVERNMENT OF NEWFOUNDLAND AND LABRADOR Department of Transportation and Infrastructure	<b>BRIDGE INSPECTION REPORT</b> <b>B09152021-3</b>	
<b>Date:</b> 3/31/2021	<b>Inspected By:</b> Paul Lawrence	<b>Category:</b> Eng. - Engineering	
<b>BRIDGE INFORMATION</b>			
<b>Site:</b>	1-247 - NEW PERLICAN RIVER BRIDGE		
<b>Route:</b>		<b>Overall Length:</b>	24.1 m
<b>Year Built:</b>	1995	<b>Est: No</b>	<b>Overall Width:</b> 10.15 m
<b>Year Last Rehab.:</b>		<b>Est: No</b>	<b>Roadway Width:</b> 8 m
<b>Region:</b>	AVALON PENINSULA	<b>Sidewalk Width:</b>	1.5 m
<b>Jurisdiction:</b>	Provincial	<b>Clearance to R.D. or N.W.L.:</b>	1.7 m
<b>Type of Structure:</b>	04 - Rigid Frame	<b>Max Depth of N.W.L.:</b>	0 m
<b>Purpose of Structure:</b>	04 - Over Non-Navigable Waters	<b>Spans:</b>	
<b>Type of Handrail:</b>	01 - Aluminum Rail	<u>Span No.:</u>	<u>Length</u>
<b>Roadway Surface:</b>	02 - Asphalt	1	13.7
<b>Alignment Vertical:</b>	01 - Good	2	0

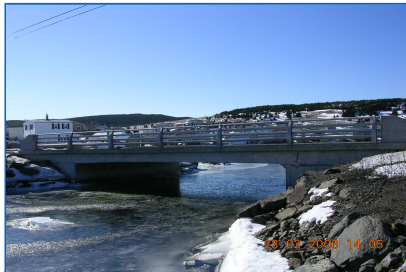
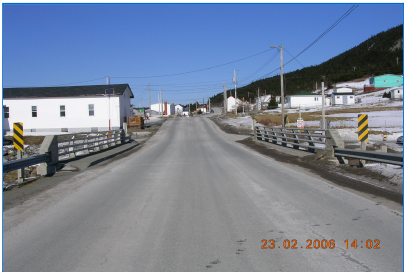
<b>Approach Rail:</b>	F2 - Fair		
<b>Comments:</b>	Some narrow cracks in edge of deck soffit and deck curbs Guiderail is damaged on 2 ends/tipped out Surface asphalt is rotted with some small potholes		
<b>HYDROLOGY</b>			
<b>Water Velocity:</b>	0 m/s	<b>Ice Problem:</b>	N - No Problem
<b>Water Depth:</b>	0 m	<b>Scour Problem:</b>	N - No Problem
<b>Waterway:</b>	01 - Adequate	<b>Debris Problem:</b>	N - No Problem
<b>Comments:</b>			
<b>REPLACEMENT/REHABILITATION</b>			
<b>Next Rehab. Date:</b>	2021	<b>Replacement Year:</b>	2021
<b>Antic. Rehab. Cost:</b>	\$0	<b>Replacement Cost:</b>	\$0
<b>Recommendations:</b>			
<b>OBSERVATIONS</b>			
<b>Overall Condition:</b>	F2 - Fair	<b>Requires Further Inspection:</b>	No
<b>Additional Observations:</b>	Guiderail needs to be repaired		
<b>LEGEND:</b>			
<b>Condition Definitions:</b>		<b>Problem Definitions:</b>	
1 - *Good - [discontinued code].	F2 - Fair.	C - Unsafe (Closed to Public).	N - No Problem.
