GOVERNMENT OF NEWFOUNDLAND AND LABRADOR Department of Transportation and Infrastructure	BRIDGE INSPECTION REPORT B05282019-4	
Date: 5/28/2019	Inspected By: Pickett R	Category: Eng. - Engineering	
BRIDGE INFORMATION			
Site:	1-023 - NORTH ARM RIVER BRIDGE #2, ROUTE 60		
Route:		Overall Length:	24.1 m
Year Built:	1926	Est: No	Overall Width: 0 m
Year Last Rehab.:		Est: No	Roadway Width: 0 m
Region:	AVALON PENINSULA	Sidewalk Width:	0 m
Jurisdiction:	Provincial	Clearance to R.D. or N.W.L.:	0 m
Type of Structure:	04 - Rigid Frame	Max Depth of N.W.L.:	0 m
Purpose of Structure:	04 - Over Non-Navigable Waters		
Type of Handrail:	03 - Timber Rail	Spans:	
Roadway Surface:	02 - Asphalt	<u>Span No.:</u>	<u>Length</u>
Alignment Vertical:	01 - Good	1	15.2
Alignment Horizontal:	01 - Good	2	0
Restrictions:	No	3	0
		<u>Span No.:</u>	<u>Length</u>
		4	0
		5	0
		6	0
BRIDGE PHOTOS

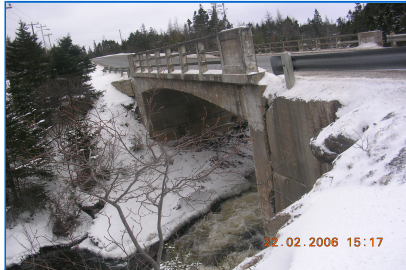
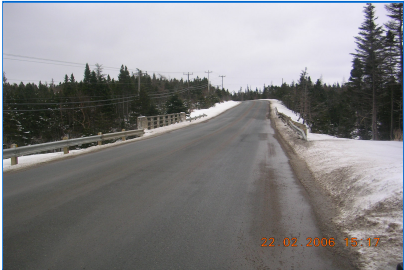
Bearing Seat:	I - Inapplicable
Comments:	Severe spalling to footing at North East and South West ends. Severe scouring under North footing and North West wing wall. Wide longitudinal cracks in North footing. Severe spalling wide cracks at wing wall to abutment joints at North West corner. Medium/wide cracks in all wingwall and abutments		
SUPERSTRUCTURE			
Condition:	F2 - Fair	Expansion Joints:	I - Inapplicable
Comments:	Rehabbed in 2018. New upstream curbs. Repaired downstream curbs. New steel railing and end blocks		
DECK			
Condition:	F2 - Fair	Curbs:	G - Good
