GOVERNMENT OF NEWFOUNDLAND AND LABRADOR Department of Transportation and Infrastructure	BRIDGE INSPECTION REPORT B09222016-1	
Date: 3/2/2016	Inspected By: Chris Lyver	Category: Eng. - Engineering	
BRIDGE INFORMATION			
Site:	1-044 - NORTH RIVER BRIDGE, CLARKE'S BEACH		
Route:	70	Overall Length:	20.6 m
Year Built:	1966	Est: No	Overall Width: 9.9 m
Year Last Rehab.:		Est: No	Roadway Width: 8.6 m
Region:	AVALON PENINSULA	Sidewalk Width:	0 m
Jurisdiction:	Provincial	Clearance to R.D. or N.W.L.:	1.9 m
Type of Structure:	01 - AASH to Girder	Max Depth of N.W.L.:	1 m
Purpose of Structure:	04 - Over Non-Navigable Waters	Spans:	
Type of Handrail:	02 - Concrete Rail	Span No.:	Length
Roadway Surface:	02 - Asphalt	1	12.3
Alignment Vertical:	01 - Good	2	0
Alignment Horizontal:	01 - Good	3	0
Restrictions:	No	4	0
		5	0
		6	0
BRIDGE PHOTOS

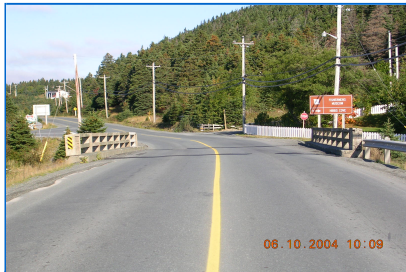
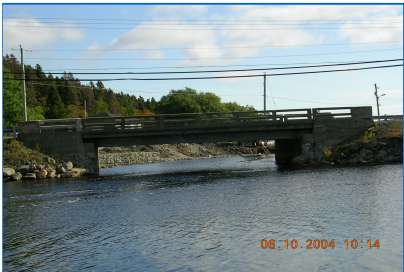
Comments:	P: NW/SW Abut corners F1: Remainder - Assumed condition of the buried/submerged reinf. conc. abut. footings - Medium erosion along abut footings that are visible through water - Very severe conc. delamin/spalling/disinteg continues to NW/SW abut. corners and exterior faces. Medium conc. spalling/disinteg with light corrosion to exposed reinf. along top of SW wingwall (under end block) - Numerous medium vert./horiz/ cracks and light delamin/spalling to 4 wingwalls - Numerous wide vertical/horizontal cracks in faces of the orig. abuts. with med. efflor. deposits - Narrow vert./horiz. cracks in faces of orig. abuts. extensions - Medium spalling to SE corner of South Abutment (extension) - Assumed condition of the bearings (inspection restricted due to height/water depth)		
SUPERSTRUCTURE			
Condition:	F1 - Fair	Expansion Joints:	F1 - Fair
Comments:	- Assumed condition of expansion joints - Girders/diaphragms remain in fair condition, (some exter. end diap's and girders covered in pigeon feces) - Medium/wide vert./horiz. cracks in 4 exterior diap's/retaining blocks - No

Condition:	F2 - Fair	Curbs:	F1 - Fair
Hand Rail:	P1 - Poor	Roadway Condition:	F1 - Fair
Approach Rail:	P3 - Poor		
Comments:	- Light honeycombing to interior deck soffit - Medium longt./trans/ vert/horiz cracks in curb/sidewalk surfaces/fascias - Narrow transverse cracks in cantilever exterior deck soffits - Const. joints between deck/curb fascias opening up - No exit guiderail NW/SE app, guiderail aging with minor damage and tipping - Deck and approaches re-surfaced since last inspection - Numerous very wide horiz./vert. cracks and severe concrete spalling/disinterg. to SE end Block. - Medium spalling to top of NW end Block

Water Velocity:	Tidal m/s	Ice Problem:	K - Known Problem
Water Depth:	Tidal m	Scour Problem:	P - Possible Problem
Waterway:	01 - Adequate	Debris Problem:	N - No Problem
Comments:	Severe slope erosion along SW wingwall - Numerous very wide horiz./vert cracks, sections with severe delamin/spalling with med. corrosion to exposed rein. on conc. handrails and NE/SW end blocks

Overall Condition:	P - Poor	Requires Further Inspection:	Yes
Additional Observations:	*- Bridge Office should re-inspect NW/SW abut. corners P: NW/SW Abut corners P1: Handrails P3: Approach rail F1: Remainder Rip-rap at SW corner of structure has migrated into channel.

Next Rehab. Date:	2016	Replacement Year:	2030
Antic. Rehab. Cost:	\$200000	Replacement Cost:	\$500000
Recommendations:	- Re-hab structure - In the interim, install new app./exit guiderail c/w haz-markers (maint). Note: Ensure guiderails (approach) extends out beyond end blocks
