GOVERNMENT OF NEWFOUNDLAND AND LABRADOR Department of Transportation and Infrastructure	BRIDGE INSPECTION REPORT B09142021-6	
Date: 2/13/2020	Inspected By: Hunt R	Category: Eng. - Engineering	
BRIDGE INFORMATION			
Site:	1-020 - O'DONNELL'S BRIDGE, ST. MARY'S BAY		
Route:		Overall Length:	33 m
Year Built:	1963	Est: No	Overall Width: 8.9 m
Year Last Rehab.:		Est: No	Roadway Width: 7.3 m
Region:	AVALON PENINSULA	Sidewalk Width:	0 m
Jurisdiction:	Provincial	Clearance to R.D. or N.W.L.:	2.4 m
Type of Structure:	01 - AASH to Girder	Max Depth of N.W.L.:	2 m
Purpose of Structure:	04 - Over Non-Navigable Waters	Spans:	
Type of Handrail:	02 - Concrete Rail	<u>Span No.:</u>	<u>Length</u>
Roadway Surface:	02 - Asphalt	<u>Span No.:</u>	<u>Length</u>
Alignment Vertical:	01 - Good	1	21.7
Alignment Horizontal:	01 - Good	2	0
Restrictions:	No	3	0
		4	0
		5	0
		6	0
BRIDGE PHOTOS			
<div style="display: flex; justify-content: space-around;">

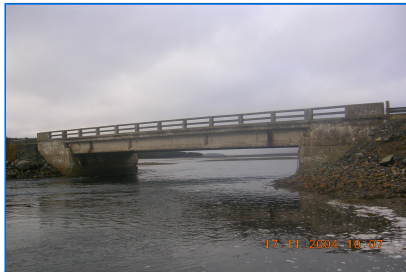
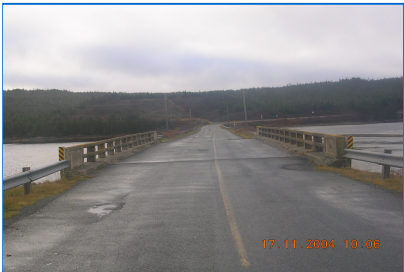
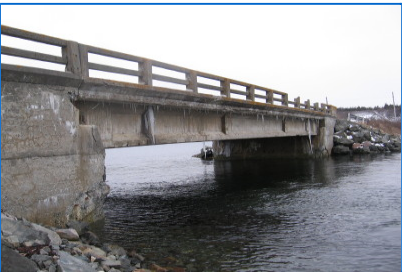
SUBSTRUCTURE			
Condition:	F2 - Fair	Bearings:	G - Good
		Bearing Seat:	G - Good
Comments:	- Hairline angular cracks in faces of wingwalls.		
SUPERSTRUCTURE			
Condition:	G - Good	Expansion Joints:	G - Good
Comments:	- CPCI 1400 girders.		
DECK			
Condition:	G - Good	Curbs:	G - Good
Hand Rail:	G - Good	Roadway Condition:	G - Good

Approach Rail:	G - Good		
Comments:	- No hazard markers at SW end (post still in place). - Hairline transverse cracks in deck soffit, - Narrow vertical cracks in concrete barrier walls.		
HYDROLOGY			
Water Velocity:	tidal m/s	Ice Problem:	P - Possible Problem
Water Depth:	tidal m	Scour Problem:	N - No Problem
Waterway:	01 - Adequate	Debris Problem:	N - No Problem
Comments:			
REPLACEMENT/REHABILITATION			
Next Rehab. Date:	2045	Replacement Year:	2090
Antic. Rehab. Cost:	\$100	Replacement Cost:	\$3500
Recommendations:	- Replace NE and SW hazard markers (maint).		
OBSERVATIONS			
Overall Condition:	G - Good	Requires Further Inspection:	No
Additional Observations:	- Remaining observations unchanged from previous inspection done in 2018		
LEGEND:			
Condition Definitions:		Problem Definitions:	
1 - *Good - [discontinued code].	F2 - Fair.	C - Unsafe (Closed to Public).	N - No Problem.
2 - *Fair - [discontinued code].	F1 - Fair.	U - Uninspectable.	P - Possible Problem.
