GOVERNMENT OF NEWFOUNDLAND AND LABRADOR Department of Transportation and Infrastructure	BRIDGE INSPECTION REPORT B06102019-4	
Date: 1/17/2019	Inspected By: Hunt R	Category: Eng. - Engineering	
BRIDGE INFORMATION			
Site:	1-160 - PICCO'S BROOK BDG, FLAT ROCK, RT.20		
Route:		Overall Length:	16.6 m
Year Built:	1989	Est: No	Overall Width: 9.7 m
Year Last Rehab.:		Est: No	Roadway Width: 6.7 m
Region:	AVALON PENINSULA	Sidewalk Width:	1.6 m
Jurisdiction:	Provincial	Clearance to R.D. or N.W.L.:	0.9 m
Type of Structure:	03 - Reinforced Concrete Beam/Slab	Max Depth of N.W.L.:	0.8 m
Purpose of Structure:	04 - Over Non-Navigable Waters	Spans:	
Type of Handrail:	01 - Aluminum Rail	Span No.:	Length
Roadway Surface:	02 - Asphalt	1	7.4
Alignment Vertical:	01 - Good	2	0
Alignment Horizontal:	02 - Adequate	3	0
Restrictions:	No	Span No.:	Length
		4	0
		5	0
		6	0
BRIDGE PHOTOS

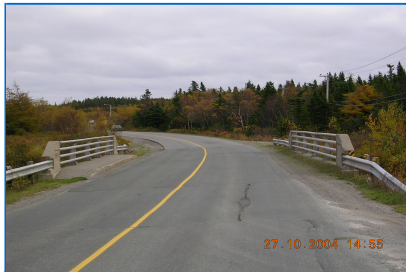
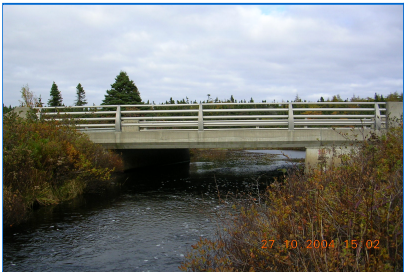
Bearing Seat:	F2 - Fair
Comments:	Assumed condition of reinforcement concrete abutment footings. Light erosion along bottom of abutment. Narrow vertical cracks with light efflor deposits in abutment faces. Inspections of bearing pads restricted due to ice and water flow. Narrow vertical cracks with medium efflor deposits in faces of wingwalls.		
SUPERSTRUCTURE			
Condition:	F2 - Fair	Expansion Joints:	F2 - Fair
Comments:	Top of North East end block sheared off (possible impact by snowplow). Minor spalling to sides of North West/South West end blocks. Narrow medium alligator cracks in all four end blocks.		
DECK			
Condition:	G - Good	Curbs:	F2 - Fair

Hand Rail:	F2 - Fair	Roadway Condition:	F2 - Fair
Approach Rail:	F2 - Fair		
Comments:	Narrow long cracks in deck soffit. Narrow horizontal vertical cracks in deck curb facias and curbs over wingwalls. Medium wide vertical transverse cracks in curb sidewalks surfaces and interior fascials. Small medium potholes in asphalt surface on deck. Medium transverse cracks in asphalt along approach slab edges. Medium damage to buried end guiderail at South East/South West end of structure. Medium dents/ scrapes to center of upstream aluminum rail.

Next Rehab. Date:	2022	Replacement Year:	2039
Antic. Rehab. Cost:	\$60	Replacement Cost:	\$700
Recommendations:	Repair damaged end block and aluminum rails at South East/South West buried ends. Install four hazard markers at corners of structure.
