GOVERNMENT OF NEWFOUNDLAND AND LABRADOR Department of Transportation and Infrastructure	BRIDGE INSPECTION REPORT B10282021-1	
Date: 10/26/2021	Inspected By: Chantel Finn	Category: Office - Bridge Office	
BRIDGE INFORMATION			
Site:	1-081 - POINT VERDE BROOK BRIDGE, GLEN'S CV		
Route:	100	Overall Length:	28.2 m
Year Built:	1973	Est: No	Overall Width: 10.2 m
Year Last Rehab.:		Est: No	Roadway Width: 9.6 m
Region:	AVALON PENINSULA	Sidewalk Width:	0.3 m
Jurisdiction:	Provincial	Clearance to R.D. or N.W.L.:	2.4 m
Type of Structure:	01 - AASH to Girder	Max Depth of N.W.L.:	1.5 m
Purpose of Structure:	04 - Over Non-Navigable Waters	Spans:	
Type of Handrail:	01 - Aluminum Rail	Span No.:	Length
Roadway Surface:	02 - Asphalt	1	20.7
Alignment Vertical:	01 - Good	2	0
Alignment Horizontal:	01 - Good	3	0
Restrictions:	No	Span No.:	Length
		4	0
		5	0
		6	0
BRIDGE PHOTOS

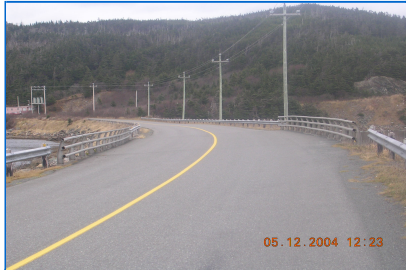
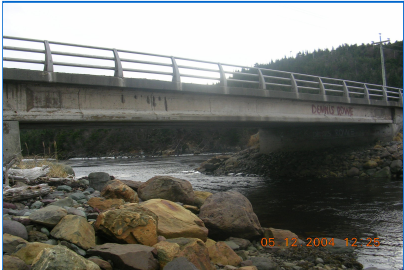
Bearing Seat:	F2 - Fair
Comments:	- Assumed condition of buried reinforced concrete abutment footings - Medium horizontal/vertical cracks in abutment faces - Light bulging and narrow cracking in some bearing pads - Hairline narrow vertical cracks in all four wingwalls (AAR)		
SUPERSTRUCTURE			
Condition:	F1 - Fair	Expansion Joints:	F1 - Fair
Comments:	- Medium/wide horizontal/longitudinal cracks in bottom flanges of most girders - Medium delamin/spalling with medium corrosion/rusting to exposed reinforcement to bottom and sides of most girders - Expansion joints are paved over with some cracking of concrete around joints to curbs fascia's - No chalking in expansion joint gaps in curb fascia's		
DECK

Condition:	F1 - Fair	Curbs:	I - Inapplicable
Hand Rail:	F1 - Fair	Roadway Condition:	F2 - Fair
Approach Rail:	P3 - Poor		
Comments:	- No end blocks or hazard markers - Narrow transverse cracks with light to medium spalling with light efflor. deposits to other areas of deck soffit and fascia's - Approach and exit rail have damage, heaving rail and rotting posts - Narrow transverse cracks in asphalt at expansion joint locations Aluminum hand rail has some damaged sections with scrapes & dents and rotting posts - Medium to severe asphalt & slope erosion at northeast, northwest, & southeast ends. - Narrow trans. cracks with light efflor. deposits in cantilevered deck soffit. - Heavy spalling on some areas of deck soffit at North end

Water Velocity:	tidal m/s	Ice Problem:	N - No Problem
Water Depth:	tidal m	Scour Problem:	N - No Problem
Waterway:	01 - Adequate	Debris Problem:	N - No Problem
Comments:	- Rip-rap at corners of structure has migrated into channel. Area affected by tides. - Numerous scrapes/ dents/ damage (esp. at ends) and alum. hand rails and end posts

Overall Condition:	P3 - Poor	Requires Further Inspection:	No
Additional Observations:	- P1 asphalt and slope erosion. - P3 aluminum handrail & approach/exit Rails. - F1 remainder.

Next Rehab. Date:	2024	Replacement Year:	2030
Antic. Rehab. Cost:	\$200000	Replacement Cost:	\$2700000
Recommendations:	- Repair all concrete defects. - Repair/replace damaged aluminum handrails & posts. - Install new end blocks with new approach-exit guiderail complete with hazard markers. - Fix asphalt and slope erosion at structure corners. - Install new hydraulic rip-rap at structure corners
