GOVERNMENT OF NEWFOUNDLAND AND LABRADOR Department of Transportation and Infrastructure	BRIDGE INSPECTION REPORT B09202021-2	
Date: 2/5/2020	Inspected By: Gillis M	Category: Eng. - Engineering	
BRIDGE INFORMATION			
Site:	1-050 - PORTUGAL COVE SOUTH BRIDGE		
Route:		Overall Length:	7 m
Year Built:	1985	Est: Yes	Overall Width: 10.7 m
Year Last Rehab.:		Est: No	Roadway Width: 9 m
Region:	AVALON PENINSULA	Sidewalk Width:	0 m
Jurisdiction:	Provincial	Clearance to R.D. or N.W.L.:	1.5 m
Type of Structure:	04 - Rigid Frame	Max Depth of N.W.L.:	0 m
Purpose of Structure:	04 - Over Non-Navigable Waters	Spans:	
Type of Handrail:	02 - Concrete Rail	<u>Span No.:</u>	<u>Length</u>
Roadway Surface:	02 - Asphalt	<u>Span No.:</u>	<u>Length</u>
Alignment Vertical:	01 - Good	1	6.2
Alignment Horizontal:	02 - Adequate	2	0
Restrictions:	No	3	0
		4	0
		5	0
		6	0
BRIDGE PHOTOS

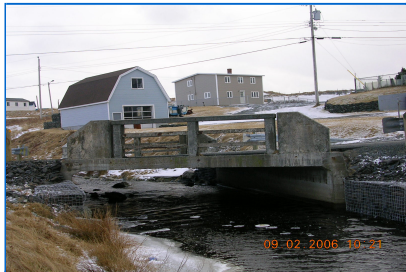
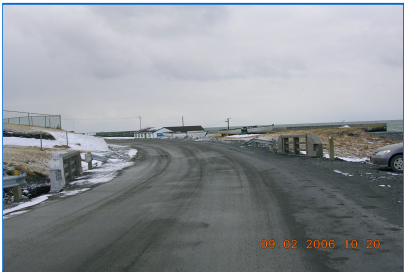
Bearing Seat:	I - Inapplicable
Comments:	- Partially exposed reinforcement frame leg footings in fairly good condition		
SUPERSTRUCTURE			
Condition:	F1 - Fair	Expansion Joints:	I - Inapplicable
Comments:	- No wingwalls in structure - Narrow vertical cracks in faces of frame legs - Narrow/med horizontal/vertical, alligator cracks and light/med spaling to 4 end blocks		
DECK			
Condition:	F2 - Fair	Curbs:	F2 - Fair
Hand Rail:	F2 - Fair	Roadway Condition:	F2 - Fair

Approach Rail:	I - Inapplicable		
Comments:	- No hazard markers - Missing approach rail, east side - Guide rail does not extend to structure - Narrow cracks in deck fascias with light efflor. deposits and also narrow cracks with med. rust to deck hand rails - Minor pot holes in asphalt, east approach		
HYDROLOGY			
Water Velocity:	0.3 m/s	Ice Problem:	N - No Problem
Water Depth:	0.3 m	Scour Problem:	N - No Problem
Waterway:	01 - Adequate	Debris Problem:	N - No Problem
Comments:	- Light to med shoulder erosion on 4 corners of structure		
REPLACEMENT/REHABILITATION			
Next Rehab. Date:	2020	Replacement Year:	2021
Antic. Rehab. Cost:	\$15	Replacement Cost:	\$300
Recommendations:			
OBSERVATIONS			
Overall Condition:	F2 - Fair	Requires Further Inspection:	No
Additional Observations:	- Install hazard markers - Install/fix guiderail approach and exit		
LEGEND:			
Condition Definitions:		Problem Definitions:	
1 - *Good - [discontinued code].	F2 - Fair.	C - Unsafe (Closed to Public).	N - No Problem.
