GOVERNMENT OF NEWFOUNDLAND AND LABRADOR Department of Transportation and Infrastructure	BRIDGE INSPECTION REPORT B06282019-3	
Date: 6/28/2019	Inspected By: Iyver C	Category: Eng. - Engineering	
BRIDGE INFORMATION			
Site:	1-328 - SHEARSTOWN OVERPASS CBN BYPASS		
Route:	75	Overall Length:	56.5 m
Year Built:	2000	Est: No	Overall Width: 11.2 m
Year Last Rehab.:		Est: No	Roadway Width: 10.4 m
Region:	AVALON PENINSULA	Sidewalk Width:	0 m
Jurisdiction:	Provincial	Clearance to R.D. or N.W.L.:	5.1 m
Type of Structure:	01 - AASH to Girder	Max Depth of N.W.L.:	0 m
Purpose of Structure:	01 - Highway Grade Separation	Spans:	
Type of Handrail:	05 - Concrete Barrier	Span No.:	Length
Roadway Surface:	01 - Concrete	1	21.5
Alignment Vertical:	01 - Good	2	21.5
Alignment Horizontal:	01 - Good	3	0
Restrictions:	No	Span No.:	Length
		4	0
		5	0
		6	0
BRIDGE PHOTOS

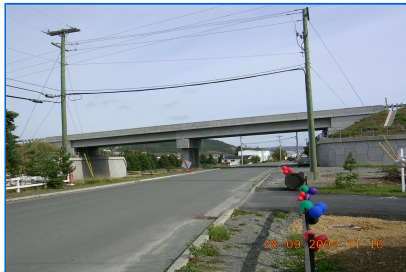
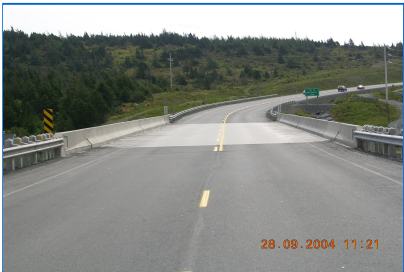
Bearing Seat:	F2 - Fair
Comments:	Pigeon content on bearing seats on abutment and pier gap. Minor damage to some MSE wall panels at South East end of south MSE wall front medium alligator cracks in pier cap, columns, exposed footing abutments and wings. Vegetation content to grow through some panels on south MSE wall.		
SUPERSTRUCTURE			
Condition:	F2 - Fair	Expansion Joints:	F2 - Fair
Comments:	Narrow angular cracks in web and bottom flanges of exterior girders near bearing seats. Girders (interior) creep blocks and diaphragm remain in fair condition.		
DECK			
Condition:	F2 - Fair	Curbs:	I - Inapplicable

Hand Rail:	F2 - Fair	Roadway Condition:	I - Inapplicable
Approach Rail:	F2 - Fair		
Comments:	Narrow transverse alligator map cracking in deck soffit (A.A.R). No hazard marker at South East end. Medium transverse longitudinal cracks, light pop outs in exposed deck. Approaches on route 75 resurfaced since last inspection. Numerous medium vertical cracks with light efflor deposits in deck curb ext facias. Numerous medium vertical alligator cracks in barrier walls (A.A.R). Numerous medium alligator cracks in barrier wall end block (A.A.R).

Next Rehab. Date:	2033	Replacement Year:	2075
Antic. Rehab. Cost:	\$250	Replacement Cost:	\$2500
Recommendations:	Monitor (A.A.R) cracking. Clean out expansion joint seals. Install missing hazard marker. Install pigeon screens on bearing seats and girder bottoms. Resurface sheartown road.
