GOVERNMENT OF NEWFOUNDLAND AND LABRADOR Department of Transportation and Infrastructure	BRIDGE INSPECTION REPORT B05282019-2	
Date: 5/28/2019	Inspected By: Hunt R	Category: Eng. - Engineering	
BRIDGE INFORMATION			
Site:	1-018 - TERRY'S BROOK BRIDGE, HARBOUR MAIN		
Route:		Overall Length:	6 m
Year Built:	1937	Est: No	Overall Width: 17.2 m
Year Last Rehab.:	1975	Est: Yes	Roadway Width: 10.5 m
Region:	AVALON PENINSULA		Sidewalk Width: 0 m
Jurisdiction:	Provincial		Clearance to R.D. or N.W.L.: 1.4 m
Type of Structure:	13 - Other		Max Depth of N.W.L.: 0.2 m
Purpose of Structure:	04 - Over Non-Navigable Waters		Spans:
Type of Handrail:	02 - Concrete Rail		<u>Span No.:</u> <u>Length</u> <u>Span No.:</u> <u>Length</u>
Roadway Surface:	02 - Asphalt		1 3.8 4 0
Alignment Vertical:	02 - Adequate		2 0 5 0
Alignment Horizontal:	02 - Adequate		3 0 6 0
Restrictions:	No		
BRIDGE PHOTOS			
<div style="display: flex; justify-content: space-around;">

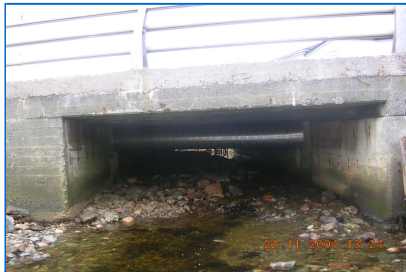
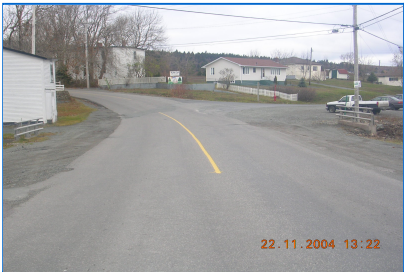
SUBSTRUCTURE			
Condition:	F1 - Fair	Bearings:	I - Inapplicable
		Bearing Seat:	I - Inapplicable
Comments:	Original structure extend 10m downstream. Assumed condition of buried/submerged reinforcement concrete frame leg footings. Extension approximately 300m higher than original structure. Curb extension done on upstream end.		
SUPERSTRUCTURE			
Condition:	F2 - Fair	Expansion Joints:	I - Inapplicable
Comments:	Sections of wingwalls that were inspected in last inspections have been removed. Some spacing still remains on abutment faces. Medium spacing to frame legs at water at South East location downstream. Construction joints of frame legs opening up (between original structure extensions).		
DECK

Condition:	F2 - Fair	Curbs:	F2 - Fair
Hand Rail:	F2 - Fair	Roadway Condition:	F2 - Fair
Approach Rail:	I - Inapplicable		
Comments:	Numerous medium wide transverse longitudinal cracks with deposits in deck surface. Deck facials have been rehabbed and aluminum handrail in good condition.

Water Velocity:	0.2 m/s	Ice Problem:	N - No Problem
Water Depth:	0.1 m	Scour Problem:	P - Possible Problem
Waterway:	01 - Adequate	Debris Problem:	P - Possible Problem
Comments:	Mass scale erosion on corners of structure. Hydraulic rip rip has been installed on downstream end and carbzons living in river basin on upstream ends.

Next Rehab. Date:	2019	Replacement Year:	2030
Antic. Rehab. Cost:	\$0	Replacement Cost:	\$400
Recommendations:	If possible some guardrail can be installed on downstream corner. Hazard marker can be installed.
