GOVERNMENT OF NEWFOUNDLAND AND LABRADOR Department of Transportation and Infrastructure	<b>BRIDGE INSPECTION REPORT</b> <b>B05022011-11</b>	
<b>Date:</b> 3/4/2011	<b>Inspected By:</b> Chris Lyver	<b>Category:</b> Eng. - Engineering	
<b>BRIDGE INFORMATION</b>			
<b>Site:</b>	1-169 - THREE MILE BRIDGE		
<b>Route:</b>	81	<b>Overall Length:</b>	11.7 m
<b>Year Built:</b>	1940	<b>Est:</b> No	<b>Overall Width:</b> 5.9 m
<b>Year Last Rehab.:</b>		<b>Est:</b> No	<b>Roadway Width:</b> 4.8 m
<b>Region:</b>	AVALON PENINSULA	<b>Sidewalk Width:</b>	0 m
<b>Jurisdiction:</b>	Provincial	<b>Clearance to R.D. or N.W.L.:</b>	1.2 m
<b>Type of Structure:</b>	04 - Rigid Frame	<b>Max Depth of N.W.L.:</b>	0.3 m
<b>Purpose of Structure:</b>	04 - Over Non-Navigable Waters		
<b>Type of Handrail:</b>	02 - Concrete Rail	<b>Spans:</b>	
<b>Roadway Surface:</b>	01 - Concrete	<u>Span No.:</u>	<u>Length</u>
<b>Alignment Vertical:</b>	02 - Adequate	1	7.4

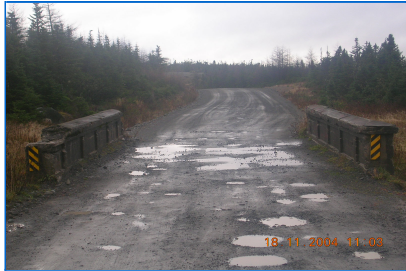
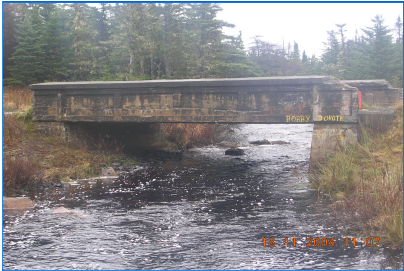
<b>SUBSTRUCTURE</b>			
<b>Condition:</b>	P1 - Poor	<b>Bearings:</b>	F1 - Fair
		<b>Bearing Seat:</b>	F1 - Fair
<b>Comments:</b>	- P-1, tops south wings - F-1, remainder. - Assumed condition of buried and submerged reinforcement concrete abutment footings. - Medium/wide vertical and horizontal cracks with light efflorescence deposits in 4 wingwalls. - Medium spalling to top of abutment/wingwall at SW corner. - Medium spalling to NW corner of north abutment. - No visible signs of bearings (possibly asphalt impregnated board).		
<b>SUPERSTRUCTURE</b>

<b>Condition:</b>	P3 - Poor	<b>Curbs:</b>	I - Inapplicable
<b>Hand Rail:</b>	P1 - Poor	<b>Roadway Condition:</b>	I - Inapplicable
<b>Approach Rail:</b>	I - Inapplicable		
<b>Comments:</b>	-P-1, surface. - F-1, soffit. - Narrow transverse cracks with light efflorescence deposits in deck soffit. - Numerous transverse flow lines in deck soffit. - Top sections of solid concrete hand rail missing at NE, SW and SE ends. - Light spalling with medium horizontal/vertical cracks on solid concrete hand rails. - Assume med. spalling still continuing on partially exposed deck (currently snow covered). - No hazard marker at SE end. - Existing hazard markers aging or painted over. - Tops of SE/SW wingwall retaining walls cracked off and tipping out. - Solid concrete handrails extend below deck approximately 100mm. - Medium delamination/spalling with medium corrosion to exposed reinforcement in soffit of solid deck hand rails. - Numerous potholes on gravel approaches and in gravel on deck.

<b>Overall Condition:</b>	P1 - Poor	<b>Requires Further Inspection:</b>	No
<b>Additional Observations:</b>	Overall Condition: P-1, deck surface, hand rails and tops of south wings. F-1, remainder. Additional Observations: - unchanged from '04 inspection. - considering its age structure remains in fair condition.

<b>Next Rehab. Date:</b>	2011	<b>Replacement Year:</b>	2025
<b>Antic. Rehab. Cost:</b>	\$50000	<b>Replacement Cost:</b>	\$300000
<b>Recommendations:</b>	- Repair hand rails, south wingwall retaining walls and deck surface. - Install short sections of approach/exit guide rail complete with hazard markers. - In the interim, install 4 new hazard markers to ends of concrete handrail (maintenance).
