GOVERNMENT OF NEWFOUNDLAND AND LABRADOR Department of Transportation and Infrastructure	BRIDGE INSPECTION REPORT B07022021-2	
Date: 1/29/2020	Inspected By: Gillis M	Category: Eng. - Engineering	
BRIDGE INFORMATION			
Site:	1-279 - TORS COVE BRIDGE (PENSTOCK)		
Route:		Overall Length:	14.7 m
Year Built:	1966	Est: Yes	Overall Width: 10.6 m
Year Last Rehab.:	1975	Est: Yes	Roadway Width: 8.7 m
Region:	AVALON PENINSULA		Sidewalk Width: 0 m
Jurisdiction:	Provincial		Clearance to R.D. or N.W.L.: 0 m
Type of Structure:	04 - Rigid Frame		Max Depth of N.W.L.: 0 m
Purpose of Structure:	04 - Over Non-Navigable Waters		Spans:
Type of Handrail:	02 - Concrete Rail		<u>Span No.:</u> <u>Length</u> <u>Span No.:</u> <u>Length</u>
Roadway Surface:	02 - Asphalt		1 4.9 4 0
Alignment Vertical:	01 - Good		2 0 5 0
Alignment Horizontal:	01 - Good		3 0 6 0
Restrictions:	No		
BRIDGE PHOTOS

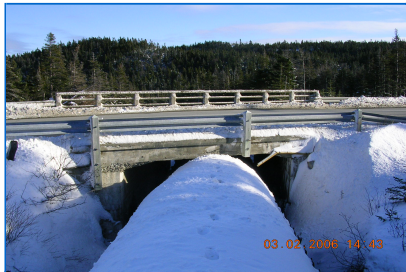
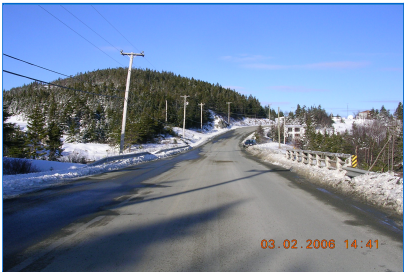
Bearing Seat:	I - Inapplicable
Comments:	Original structure extended downstream (east side). No footings on original structure. Abutment poured on high bedrock. Extension abutments poured on low bedrock. Penstock is close to abutments, limited abutments. Scour area on North abutment.		
SUPERSTRUCTURE			
Condition:	F1 - Fair	Expansion Joints:	I - Inapplicable
Comments:	Medium vertical cracks with light efflor. deposits in faces of abutment and wingwalls. Some heavy efflor. deposits to west abutment corners.		
DECK			
Condition:	F1 - Fair	Curbs:	P3 - Poor

Hand Rail:	F1 - Fair	Roadway Condition:	P3 - Poor
Approach Rail:	F2 - Fair		
Comments:	Numerous narrow transverse cracks with light efflor deposits in deck soffit. No hazard markers on NE/SE end of concrete handrail. Medium delamination/spalling to outside deck edge/soffit/fascia on west end. Wide cracks and medium spalling to handrail and posts. Medium delamination/spalling with medium corrosion to exposed reinforcement to top of curb at SW end. Some minor dents to guiderail, 1 cracked post on west side.

Next Rehab. Date:	2020	Replacement Year:	2026
Antic. Rehab. Cost:	\$30000	Replacement Cost:	\$450000
Recommendations:	repair concrete defects. Install hazard markers on east sides of structure. Fix guide post and install guiderail reflectors.
