GOVERNMENT OF NEWFOUNDLAND AND LABRADOR Department of Transportation and Infrastructure	BRIDGE INSPECTION REPORT B07022021-1	
Date: 1/29/2020	Inspected By: Hunt R	Category: Eng. - Engineering	
BRIDGE INFORMATION			
Site:	1-074 - TORS COVE POND SPILLWAY CULVERT		
Route:		Overall Length:	21.6 m
Year Built:	1966	Est: Yes	Overall Width: 11.2 m
Year Last Rehab.:	2000	Est: No	Roadway Width: 7.1 m
Region:	AVALON PENINSULA		Sidewalk Width: 0 m
Jurisdiction:	Provincial		Clearance to R.D. or N.W.L.: 3.3 m
Type of Structure:	04 - Rigid Frame		Max Depth of N.W.L.: 0.2 m
Purpose of Structure:	04 - Over Non-Navigable Waters		Spans:
Type of Handrail:	06 - None		<u>Span No.:</u> <u>Length</u> <u>Span No.:</u> <u>Length</u>
Roadway Surface:	02 - Asphalt		1 4.4 4 0
Alignment Vertical:	01 - Good		2 0 5 0
Alignment Horizontal:	01 - Good		3 0 6 0
Restrictions:	No		
BRIDGE PHOTOS			
<div style="display: flex; justify-content: space-around;">

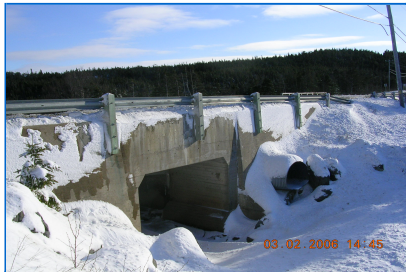
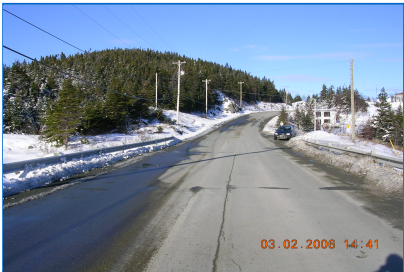
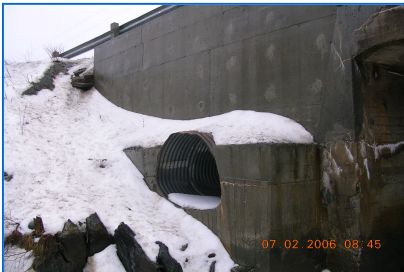
SUBSTRUCTURE			
Condition:	F1 - Fair	Bearings:	I - Inapplicable
		Bearing Seat:	I - Inapplicable
Comments:	Original frame legs extended 5.0m upstream and 3.0m downstream. Extensions are 0.75m higher than original structure. Medium scour continues under original frame leg footings. Medium erosion along faces of upstream extension footings.		
SUPERSTRUCTURE			
Condition:	F1 - Fair	Expansion Joints:	I - Inapplicable
Comments:	No visible signs of expansion joints. Numerous wide horizontal/vertical cracks in faces of original frame legs. Narrow horizontal/vertical cracks in faces of frame leg extensions. Medium delamination/spalling to NW corner of North frame leg.		
DECK

Condition:	P1 - Poor	Curbs:	I - Inapplicable
Hand Rail:	I - Inapplicable	Roadway Condition:	I - Inapplicable
Approach Rail:	F1 - Fair		
Comments:	F2 -extensions, P - Original. Severe delamination, disintegration spalling with severe rusting to exposed reinforcement beam and rebar on original deck edges and fascia. Severe disintegration, spalling with medium rusting to exposed reinforcement to upstream deck fascia on extensions. Narrow wide longitudinal/transverse cracks in original deck soffit. Narrow cracks in deck soffits on extensions. Numerous cracks, dips, small potholes in Rte 10 road surface.

Water Velocity:	0.0 m/s	Ice Problem:	N - No Problem
Water Depth:	0.0 m	Scour Problem:	K - Known Problem
Waterway:	01 - Adequate	Debris Problem:	P - Possible Problem
Comments:	Some medium shoulder erosion

Overall Condition:	P1 - Poor	Requires Further Inspection:	Yes
Additional Observations:	P1 - Original rigid frame. F1 - Extensions. Overflow arch 1500Wx1200H through south wingwalls.

Next Rehab. Date:	2020	Replacement Year:	2025
Antic. Rehab. Cost:	\$100000	Replacement Cost:	\$600000
Recommendations:	Repair concrete defects. Repair scour problem. Repair guiderail and resurface Route 10. Bridge office should re-inspect original rigid frame
