GOVERNMENT OF NEWFOUNDLAND AND LABRADOR Department of Transportation and Infrastructure	BRIDGE INSPECTION REPORT B08202021-4	
Date: 8/12/2021	Inspected By: Mike Button	Category: Office - Bridge Office	
BRIDGE INFORMATION			
Site:	1-321 - TURK'S WATER BRIDGE OVER GOULD'S BROOK		
Route:	71	Overall Length:	14.45 m
Year Built:	1960	Est: Yes	Overall Width: 4.4 m
Year Last Rehab.:		Est: No	Roadway Width: 5 m
Region:	AVALON PENINSULA	Sidewalk Width:	0 m
Jurisdiction:	Provincial	Clearance to R.D. or N.W.L.:	0.9 m
Type of Structure:	11 - Timber Bridge	Max Depth of N.W.L.:	0.6 m
Purpose of Structure:	04 - Over Non-Navigable Waters	Spans:	
Type of Handrail:	03 - Timber Rail	Span No.:	Length
Roadway Surface:	03 - Timber	1	6
Alignment Vertical:	01 - Good	2	6
Alignment Horizontal:	01 - Good	3	0
Restrictions:	Yes	Span No.:	Length
Describe Restrictions:	1 lane traffic	4	0
		5	0
		6	0
BRIDGE PHOTOS

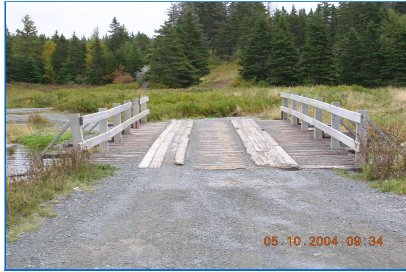
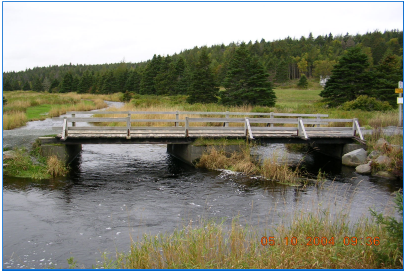
Condition:	P3 - Poor	Bearings:	I - Inapplicable
		Bearing Seat:	P3 - Poor
Comments:	- Upstream side of pier is severely deteriorated with large cracks/spalls vegetation growing out of spalls. - Both abutments have wide vertical cracks from the water level to top of concrete. - Bearing areas on the south abutment have large spalls near creosote beams (P3). 12x12" creosote beams extend ~1m beyond both abutments and are buried into the ground. - North abutment bearing areas F1.		
SUPERSTRUCTURE			
Condition:	F1 - Fair	Expansion Joints:	I - Inapplicable
Comments:	- 12x12" creosote beams in fair condition with mild splitting.		
DECK

Condition:	P1 - Poor	Curbs:	I - Inapplicable
Hand Rail:	P - Poor	Roadway Condition:	I - Inapplicable
Approach Rail:	I - Inapplicable		
Comments:	- Handrail posts toe-nailed to deck in some locations, 2x6" rails missing and with some cut. - No app/exit rails. - No curb or hazard markers. - Timber decking heavily worn with numerous splits. - Underside of deck uninspectable, but open to elements.

Water Velocity:	0.1 m/s	Ice Problem:	P - Possible Problem
Water Depth:	1.0 m	Scour Problem:	P - Possible Problem
Waterway:	01 - Adequate	Debris Problem:	N - No Problem
Comments:	- Deep water prevented scour inspection.

Overall Condition:	P1 - Poor	Requires Further Inspection:	No
Additional Observations:	- Structure leads to atv trail. Services no homes. - Licensed Salmon River. - Structure not professionally maintained, handrail modifications likely completed by locals in the area. - Vertical alignment on south approach very steep. Hazards: Deep water, missing handrails to Brook below.

Next Rehab. Date:		Replacement Year:	2022
Antic. Rehab. Cost:	\$0	Replacement Cost:	\$200000
Recommendations:	- If structure is the responsibility of T&I, replace the structure. - 12x12" creosote timbers likely re-useable. Abutments, pier, handrails, and timber decking need replacement.
