GOVERNMENT OF NEWFOUNDLAND AND LABRADOR Department of Transportation and Works	BRIDGE INSPECTION REPORT B07302018-5 Printed: Wednesday, October 3, 2018	
Date: 7/23/2018	Inspected By: Parsons R	Category: Maint. - Maintenance	
BRIDGE INFORMATION			
Site:	1-305 - WESTERN BAY BROOK BRIDGE NO.2		
Route:		Overall Length:	11.7 m
Year Built:	1970	Est: No	Overall Width: 10.8 m
Year Last Rehab.:		Est: No	Roadway Width: 6.7 m
Region:	AVALON PENINSULA	Sidewalk Width:	0 m
Jurisdiction:	Provincial	Clearance to R.D. or N.W.L.:	2.7 m
Type of Structure:	02 - Double Tee	Max Depth of N.W.L.:	0.5 m
Purpose of Structure:	04 - Over Non-Navigable Waters	Spans:	
Type of Handrail:	04 - Steel Rail	<u>Span No.:</u>	<u>Length</u>
Roadway Surface:	02 - Asphalt	Span No.: 1	<u>Length</u> 6.4
Alignment Vertical:	02 - Adequate	Span No.: 2	<u>Length</u> 0
Alignment Horizontal:	02 - Adequate	Span No.: 3	<u>Length</u> 0
Restrictions:	No

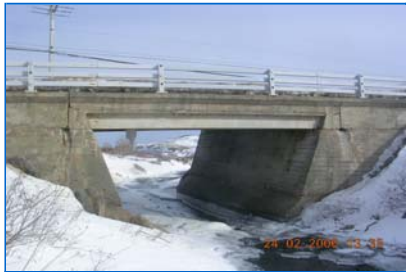
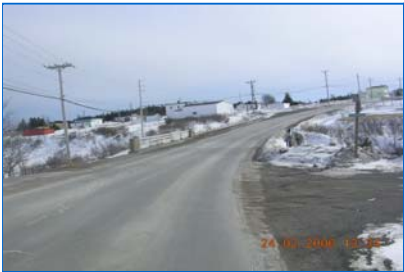
BRIDGE PHOTOS

SUBSTRUCTURE			
Condition:	F2 - Fair (Inspection within 2 Years)	Bearings:	F2 - Fair (Inspection within 2 Years)
		Bearing Seat:	F2 - Fair (Inspection within 2 Years)
Comments:	- Footings scoured and deteriorated with some undermining. - Some cracks in bearing seats.		
SUPERSTRUCTURE			
Condition:	F2 - Fair (Inspection within 2 Years)	Expansion Joints:	U - Uninspectable
Comments:	- Expansion joints paved over. - Cracks on inlet side both abutments have steel exposed. - Second beam significantly deteriorated with exposed steel.		
DECK			
Condition:	F2 - Fair (Inspection within 2 Years)	Curbs:	F1 - Fair (Inspection within 1 Year)
Hand Rail:	C - Unsafe (Closed to Public)	Roadway Condition:	F1 - Fair (Inspection within 1 Year)

Approach Rail:	G - Good (Inspection within 2 Years)		
Comments:	- Rail nd rail footing in poor condition.		
HYDROLOGY			
Water Velocity:	0 m/s	Ice Problem:	N - No Problem
Water Depth:	0.5 m	Scour Problem:	K - Known Problem
Waterway:	01 - Adequate	Debris Problem:	P - Possible Problem
Comments:			
REPLACEMENT/REHABILITATION			
Next Rehab. Date:	2018	Replacement Year:	2018
Antic. Rehab. Cost:	\$0.00	Replacement Cost:	\$0.00
Recommendations:			
OBSERVATIONS			
Overall Condition:	F2 - Fair (Inspection within 2 Years)	Requires Further Inspection:	Yes
Additional Observations:	- Rail and rail footing in poor condition check underside beam.		
LEGEND:			
Condition Definitions:			
1 - *Good - [discontinued code].	F2 - Fair (Inspection within 2 Years).	C - Unsafe (Closed to Public).	Problem Definitions:
2 - *Fair - [discontinued code].	F1 - Fair (Inspection within 1 Year).	U - Uninspectable.	N - No Problem.
3 - *Poor - [discontinued code].	P3 - Poor (Repair within 3 Years).	I - Inapplicable.	P - Possible Problem.
