GOVERNMENT OF NEWFOUNDLAND AND LABRADOR Department of Transportation and Infrastructure		BRIDGE INSPECTION REPORT B05052006-7	
Date: 3/3/2006		Inspected By: Pickett R		Category: Eng. - Engineering	
BRIDGE INFORMATION					
Site:	1-000 - WESTERN GULLY BROOK BRIDGE, PORTUGAL COVE				
Route:	40	Overall Length:	6.3 m		
Year Built:	1960	Est: No	Overall Width:	9.8 m	
Year Last Rehab.:		Est: No	Roadway Width:	9.2 m	
Region:	AVALON PENINSULA		Sidewalk Width:	0 m	
Jurisdiction:	Federal	Clearance to R.D. or N.W.L.:	1.3 m		
Type of Structure:	04 - Rigid Frame	Max Depth of N.W.L.:	0.2 m		
Purpose of Structure:	04 - Over Non-Navigable Waters		Spans:		
Type of Handrail:	02 - Concrete Rail		<u>Span No.:</u>	<u>Length</u>	<u>Span No.:</u>
Roadway Surface:	02 - Asphalt		1	3	4
Alignment Vertical:	01 - Good		2	0	5
Alignment Horizontal:	02 - Adequate		3	0	6
Restrictions:	No				
BRIDGE PHOTOS

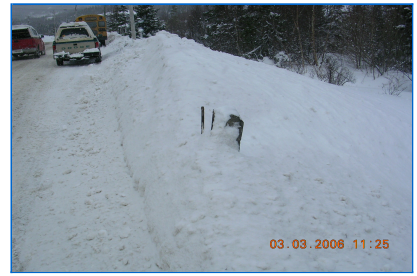
Approach Rail: I - Inapplicable
Comments: - Handrail downstream has only vertical concrete up - Upstream handrail OK

Description:
Handrail damage

Next Rehab. Date: 2007	Replacement Year: 2009
Antic. Rehab. Cost: \$15000	Replacement Cost: \$100000
Recommendations: - Repair handrail on downstream end - Install approach rail

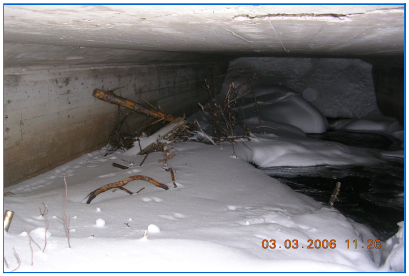
Water Velocity: 2.0 m/s	Ice Problem: P - Possible Problem
Water Depth: 0.3 m	Scour Problem: P - Possible Problem
Waterway: 01 - Adequate	Debris Problem: P - Possible Problem
Comments: - Outlet completely blocked with snow - Some debris in structure now

Description:
Debris under structure
