GOVERNMENT OF NEWFOUNDLAND AND LABRADOR Department of Transportation and Infrastructure	BRIDGE INSPECTION REPORT B11152021-3	
Date: 10/19/2021	Inspected By: Mike Button	Category: Office - Bridge Office	
BRIDGE INFORMATION			
Site:	1-209 - WESTERN POND BROOK BRIDGE		
Route:		Overall Length:	7.4 m
Year Built:	1970	Est: No	Overall Width: 7.2 m
Year Last Rehab.:		Est: No	Roadway Width: 4.4 m
Region:	AVALON PENINSULA	Sidewalk Width:	0 m
Jurisdiction:	Provincial	Clearance to R.D. or N.W.L.:	1.5 m
Type of Structure:	03 - Reinforced Concrete Beam/Slab	Max Depth of N.W.L.:	0.4 m
Purpose of Structure:	04 - Over Non-Navigable Waters	Spans:	
Type of Handrail:	02 - Concrete Rail	Span No.:	Length
Roadway Surface:	02 - Asphalt	1	6.5
Alignment Vertical:	01 - Good	2	0
Alignment Horizontal:	01 - Good	3	0
Restrictions:	No	6	0
BRIDGE PHOTOS

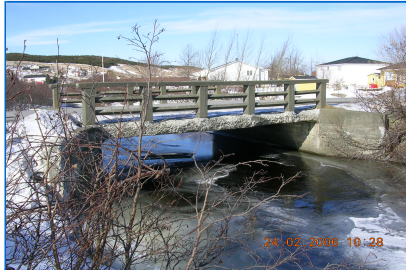
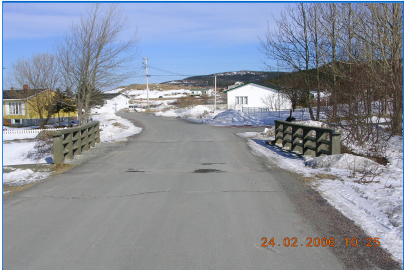
SUBSTRUCTURE			
Condition:	F1 - Fair	Bearings:	I - Inapplicable
		Bearing Seat:	F1 - Fair

Comments:	- Mild concrete erosion at the waterline level on both frame legs. Narrow horizontal vertical cracking throughout both frame legs. Frame legs generally in fair condition, F1. - Several medium-wide cracks with light efflorescence deposits & severe delamination/spalling to many areas on the four wing walls. - Bearing seat/frame leg transition to deck joint in fair condition.		
SUPERSTRUCTURE			
Condition:	F1 - Fair	Expansion Joints:	F1 - Fair
Comments:	- Wide transverse cracks at expansion joints locations, if there are any. No visible leakage seen on frame legs below, F1. - Eastern third of the bottom of the deck has medium map cracking with medium efflorescence, F1 for now. Remainder of bottom of deck, F2. - South fascia is disintegrated on the southeast corner, and has undermined the handrail, P3. North fascia in fair condition with mild disintegration on the northeast corner, F1.

DECK			
Condition:	F1 - Fair	Curbs:	I - Inapplicable
Hand Rail:	P1 - Poor	Roadway Condition:	P3 - Poor
Approach Rail:	I - Inapplicable		
Comments:	- No curbs. Shoulder of the road on the bridge has heavy vegetation. - Asphalt has approach settlement on both sides and has pooling water. At the expansion joint locations, there are large wide transverse cracks, P3. - No end blocks, hazard markers or approach/exit guiderail. - Handrail in fair condition with the exception of the northwest corner, area made of 2x6 planks and post, P1.		
HYDROLOGY			
Water Velocity:	0.2 m/s	Ice Problem:	N - No Problem
Water Depth:	0.2 m	Scour Problem:	N - No Problem
Waterway:	01 - Adequate	Debris Problem:	P - Possible Problem
Comments:	- Heavy vegetation growth around stream, rip-rap out of position but the flow rate is low.		
REPLACEMENT/REHABILITATION			
Next Rehab. Date:	2024	Replacement Year:	2030
Antic. Rehab. Cost:	\$30,000	Replacement Cost:	\$500,000

Recommendations:	- Replace handrail, rehab the exterior fascia's, repair approaches/repave and trim back vegetation. Consider replacement with a multi-plate or culvert.		
OBSERVATIONS			
Overall Condition:	F1 - Fair	Requires Further Inspection:	No
Additional Observations:	- Hazards, limited traffic, navigating heavy vegetation.		
LEGEND:			
Condition Definitions:		Problem Definitions:	
1 - *Good - [discontinued code].	F2 - Fair.	C - Unsafe (Closed to Public).	N - No Problem.
2 - *Fair - [discontinued code].	F1 - Fair.	U - Uninspectable.	P - Possible Problem.
3 - *Poor - [discontinued code].	P3 - Poor.	I - Inapplicable.	K - Known Problem.
4 - *Unsafe - [discontinued code].	P1 - Poor.		NA - Not Applicable.
G - Good.	P - Poor.		
Category Definitions:			
Mant. - Maintenance.			
Eng. - Engineering.			
Office - Bridge Office.			
PHOTO GUIDELINES:			
Inspection Photos:			
Please provide photos using guidelines below:
