GOVERNMENT OF NEWFOUNDLAND AND LABRADOR Department of Transportation and Infrastructure	BRIDGE INSPECTION REPORT B09152021-10	
Date: 4/27/2020	Inspected By: Hunt R	Category: Eng. - Engineering	
BRIDGE INFORMATION			
Site:	1-069 - WHITEWAY BRIDGE		
Route:	80	Overall Length:	16.4 m
Year Built:	1971	Est: No	Overall Width: 11.3 m
Year Last Rehab.:		Est: No	Roadway Width: 8.8 m
Region:	AVALON PENINSULA	Sidewalk Width:	1.75 m
Jurisdiction:	Provincial	Clearance to R.D. or N.W.L.:	3.1 m
Type of Structure:	02 - Double Tee	Max Depth of N.W.L.:	0.4 m
Purpose of Structure:	04 - Over Non-Navigable Waters	Spans:	
Type of Handrail:	02 - Concrete Rail	<u>Span No.:</u>	<u>Length</u>
Roadway Surface:	02 - Asphalt	1	9.7
Alignment Vertical:	02 - Adequate	2	0
Alignment Horizontal:	02 - Adequate	3	0
Restrictions:	No	4	0
		5	0
		6	0
BRIDGE PHOTOS

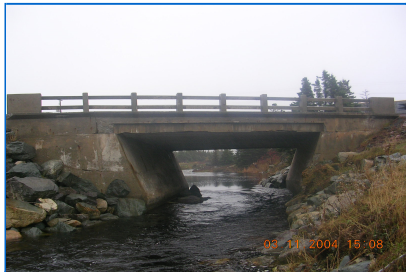
Comments:	- No footings, abutments poured directly onto bedrock. - Medium erosion and scour under both abutments. - Narrow vert./ alligator cracking with light efflor. deposits in abutment faces. - Medium spalling along exterior faces of north bearing seats. - Flow lines opening up in abutment faces. - Medium spalling/scaling and map cracking in 4 wingwalls - Severe delamin./ spalling/ disintegration to 4 corner creep blocks and exterior faces of bearing seats. - Medium erosion along bottom faces of abutments		
SUPERSTRUCTURE			
Condition:	P1 - Poor	Expansion Joints:	F1 - Fair
Comments:	- P1 (extension tees). - F1 (remainder). - Severe delamin./ spalling with medium rusting to exposed reinf. and stressing cables on U/S and D/S exterior tees - Wide horiz. cracks at ends of some tees. - Remaining interior tees have medium spalling/ delamin. with medium rusting to exposed reinf. (insuff cover). - No visible signs of expansion joints, no chaulking in exp. gaps in curbs.

DECK			
Condition:	F1 - Fair	Curbs:	P3 - Poor
Hand Rail:	P1 - Poor	Roadway Condition:	P3 - Poor
Approach Rail:	F2 - Fair		
Comments:	- Curbs and sidewalk have medium spalling/ abrasion with medium trans./ vert. cracks. Ext. deck/curb fascias have med. trans./horiz. cracks with med. delamin./ spalling. - Some asphalt settlement at exp. joint locations. - Numerous med./large alligator cracks and medium/ severe spalling to 4 end blocks. - Numerous wide horiz. cracks and medium spalling to exposed reinf. at concrete handrails. - Minor scrapes, dents, damage and tipping posts to app./ exit guiderail.		
HYDROLOGY			
Water Velocity:	0.5 m/s	Ice Problem:	N - No Problem
Water Depth:	0.5 m	Scour Problem:	K - Known Problem
Waterway:	01 - Adequate	Debris Problem:	N - No Problem
Comments:	- Some D/S rip-rap has migrated into channel. - Some shoulder erosion at 4 corners of structure.		
REPLACEMENT/REHABILITATION

Next Rehab. Date:	2021	Replacement Year:	2021
Antic. Rehab. Cost:	\$250	Replacement Cost:	\$1500
Recommendations:	- Repair all concrete defects (esp. double tees). Correct scour problem. - Install new handrails, end blocks and curbs. - Install new exp. joints. Correct shoulder erosion and install extra rip-rap		
OBSERVATIONS			
Overall Condition:	P1 - Poor	Requires Further Inspection:	Yes
Additional Observations:	- Bridge office should re-inspect double tees and scour problem - P1 (scour/ double tees). - F1 (remainder).		
LEGEND:			
Condition Definitions:		Problem Definitions:	
1 - *Good - [discontinued code].	F2 - Fair.	C - Unsafe (Closed to Public).	N - No Problem.
2 - *Fair - [discontinued code].	F1 - Fair.	U - Uninspectable.	P - Possible Problem.
3 - *Poor - [discontinued code].	P3 - Poor.	I - Inapplicable.	K - Known Problem.
4 - *Unsafe - [discontinued code].	P1 - Poor.		NA - Not Applicable.
G - Good.	P - Poor.
