GOVERNMENT OF NEWFOUNDLAND AND LABRADOR Department of Transportation and Infrastructure	<b>BRIDGE INSPECTION REPORT</b> <b>B01202020-43</b>	
<b>Date:</b> 8/28/2019	<b>Inspected By:</b> Lynch R / Martin L	<b>Category:</b> Eng. - Engineering	
<b>BRIDGE INFORMATION</b>			
<b>Site:</b>	3-074 - CAT HARBOUR BROOK BOX CULVERT, LUMSDEN		
<b>Route:</b>		<b>Overall Length:</b>	0 m
<b>Year Built:</b>	1969	<b>Est: Yes</b>	<b>Overall Width:</b> 0 m
<b>Year Last Rehab.:</b>		<b>Est: No</b>	<b>Roadway Width:</b> 0 m
<b>Region:</b>	CENTRAL WEST	<b>Sidewalk Width:</b>	0 m
<b>Jurisdiction:</b>	Provincial	<b>Clearance to R.D. or N.W.L.:</b>	0 m
<b>Type of Structure:</b>	13 - Other	<b>Max Depth of N.W.L.:</b>	0 m
<b>Purpose of Structure:</b>	04 - Over Non-Navigable Waters		
<b>Type of Handrail:</b>	06 - None	<b>Spans:</b>	
<b>Roadway Surface:</b>	02 - Asphalt	<u>Span No.:</u>	<u>Length</u>
<b>Alignment Vertical:</b>	01 - Good	1	0

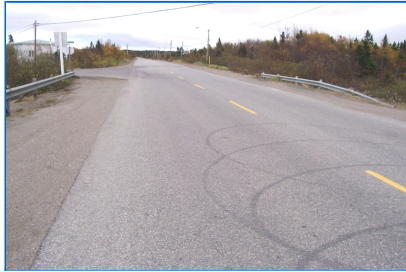
<b>SUBSTRUCTURE</b>			
<b>Condition:</b>	F2 - Fair	<b>Bearings:</b>	I - Inapplicable
		<b>Bearing Seat:</b>	I - Inapplicable
<b>Comments:</b>	Creosote bottom of culvert appears solid. Center support slightly tipped.		
<b>SUPERSTRUCTURE</b>			
<b>Condition:</b>	F2 - Fair	<b>Expansion Joints:</b>	I - Inapplicable
<b>Comments:</b>	No settlement, cracks in asphalt.		
<b>DECK</b>			
<b>Condition:</b>	F2 - Fair	<b>Curbs:</b>	I - Inapplicable
<b>Hand Rail:</b>	I - Inapplicable	<b>Roadway Condition:</b>	I - Inapplicable

<b>Approach Rail:</b>	I - Inapplicable		
<b>Comments:</b>			
<b>HYDROLOGY</b>			
<b>Water Velocity:</b>	0 m/s	<b>Ice Problem:</b>	N - No Problem
<b>Water Depth:</b>	0 m	<b>Scour Problem:</b>	N - No Problem
<b>Waterway:</b>	01 - Adequate	<b>Debris Problem:</b>	P - Possible Problem
<b>Comments:</b>	Heavy alders left and RHSs.		
<b>REPLACEMENT/REHABILITATION</b>			
<b>Next Rehab. Date:</b>		<b>Replacement Year:</b>	
<b>Antic. Rehab. Cost:</b>	\$0	<b>Replacement Cost:</b>	\$0
<b>Recommendations:</b>	Some cracking and splitting with minor rot at timber ends.		
<b>OBSERVATIONS</b>			
<b>Overall Condition:</b>	F2 - Fair	<b>Requires Further Inspection:</b>	No
<b>Additional Observations:</b>	Install new rail and hazard markers. Cut brush upstream.		
<b>LEGEND:</b>			
<b>Condition Definitions:</b>		<b>Problem Definitions:</b>	
1 - *Good - [discontinued code].	F2 - Fair.	C - Unsafe (Closed to Public).	N - No Problem.
