GOVERNMENT OF NEWFOUNDLAND AND LABRADOR Department of Transportation and Infrastructure	BRIDGE INSPECTION REPORT B07222021-3	
Date: 7/7/2021	Inspected By: McCaw J	Category: Eng. - Engineering	
BRIDGE INFORMATION			
Site:	3-097 - EAST BROOK BRIDGE (BURLINGTON)		
Route:		Overall Length:	12.8 m
Year Built:	1970	Est: Yes	Overall Width: 10 m
Year Last Rehab.:	2004	Est: No	Roadway Width: 7.4 m
Region:	CENTRAL WEST	Sidewalk Width:	0 m
Jurisdiction:	Provincial	Clearance to R.D. or N.W.L.:	2.5 m
Type of Structure:	02 - Double Tee	Max Depth of N.W.L.:	1 m
Purpose of Structure:	04 - Over Non-Navigable Waters		
Type of Handrail:	01 - Aluminum Rail		
Roadway Surface:	02 - Asphalt	Spans:	
Alignment Vertical:	01 - Good	<u>Span No.:</u>	<u>Length</u>
Alignment Horizontal:	01 - Good	<u>Span No.:</u>	<u>Length</u>
Restrictions:	No	1	12.8
		2	0
		3	0
		4	0
		5	0
		6	0
BRIDGE PHOTOS

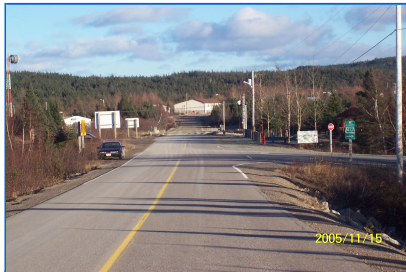
Bearing Seat:	F2 - Fair
Comments:	Joints leaking onto abutments. Erosion occurring around wingwall.		
SUPERSTRUCTURE			
Condition:	F2 - Fair	Expansion Joints:	P1 - Poor
Comments:	Leaking through joints onto girders. Expansion joints missing sections or rusted through.		
DECK			
Condition:	F1 - Fair	Curbs:	F1 - Fair
Hand Rail:	F1 - Fair	Roadway Condition:	F1 - Fair

Approach Rail:	F1 - Fair		
Comments:	Several potholes on surface of deck and approaches. Some spalling present on curb. Deck drains blocked with sand and debris.		
HYDROLOGY			
Water Velocity:	0.3 m/s	Ice Problem:	N - No Problem
Water Depth:	0.6 m	Scour Problem:	N - No Problem
Waterway:	01 - Adequate	Debris Problem:	N - No Problem
Comments:			
REPLACEMENT/REHABILITATION			
Next Rehab. Date:	2025	Replacement Year:	2040
Antic. Rehab. Cost:	\$80000	Replacement Cost:	\$1500000
Recommendations:	Replace expansion joints, repair deck and curbs. Install structural guiderail. Correct erosion.		
OBSERVATIONS			
Overall Condition:	F2 - Fair	Requires Further Inspection:	No
Additional Observations:	P3 - Expansion joints, F1-F2 remainder. Parking ok. hazards: traffic, water, slipping		
LEGEND:			
Condition Definitions:			
1 - *Good - [discontinued code].	F2 - Fair.	C - Unsafe (Closed to Public).	Problem Definitions:
2 - *Fair - [discontinued code].	F1 - Fair.	U - Uninspectable.	N - No Problem.
