GOVERNMENT OF NEWFOUNDLAND AND LABRADOR Department of Transportation and Infrastructure	<b>BRIDGE INSPECTION REPORT</b> <b>B12152017-3</b>	
<b>Date:</b> 11/21/2017	<b>Inspected By:</b> Burke/Sharron	<b>Category:</b> Eng. - Engineering	
<b>BRIDGE INFORMATION</b>			
<b>Site:</b>	3-065 - FURBYS COVE BRIDGE		
<b>Route:</b>		<b>Overall Length:</b>	0 m
<b>Year Built:</b>	1972	<b>Est: Yes</b>	<b>Overall Width:</b> 0 m
<b>Year Last Rehab.:</b>	1995	<b>Est: No</b>	<b>Roadway Width:</b> 0 m
<b>Region:</b>	CENTRAL WEST	<b>Sidewalk Width:</b>	0 m
<b>Jurisdiction:</b>	Municipal	<b>Clearance to R.D. or N.W.L.:</b>	0 m
<b>Type of Structure:</b>	11 - Timber Bridge	<b>Max Depth of N.W.L.:</b>	0 m
<b>Purpose of Structure:</b>	04 - Over Non-Navigable Waters	<b>Spans:</b>	
<b>Type of Handrail:</b>	03 - Timber Rail	<u>Span No.:</u>	<u>Length</u>
<b>Roadway Surface:</b>	03 - Timber	1	0
<b>Alignment Vertical:</b>	01 - Good	2	0

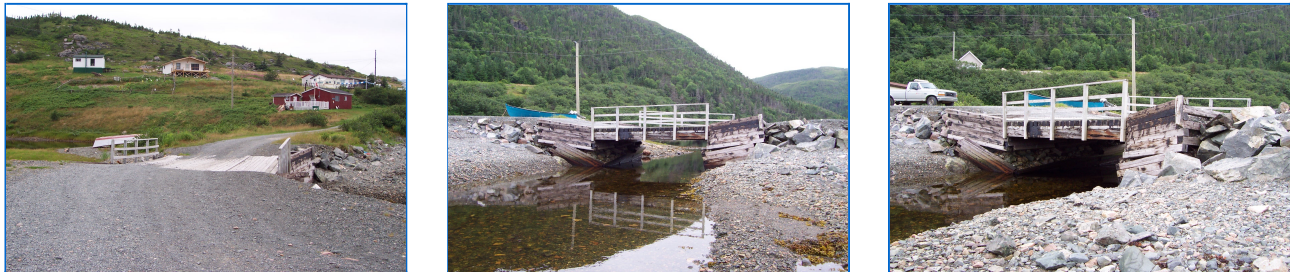
<b>SUBSTRUCTURE</b>			
<b>Condition:</b>	P1 - Poor	<b>Bearings:</b>	I - Inapplicable
		<b>Bearing Seat:</b>	I - Inapplicable
<b>Comments:</b>	Abutment # 2 settled and tipped. Possible scour underneath.		
<b>SUPERSTRUCTURE</b>			
<b>Condition:</b>	P - Poor	<b>Expansion Joints:</b>	I - Inapplicable
<b>Comments:</b>	Steel is on an angle. Buckled on downstream. Starting to rust.		
<b>DECK</b>			
<b>Condition:</b>	F1 - Fair	<b>Curbs:</b>	I - Inapplicable
<b>Hand Rail:</b>	F2 - Fair	<b>Roadway Condition:</b>	I - Inapplicable

<b>Approach Rail:</b>	I - Inapplicable		
<b>Comments:</b>	Deck & handrail recently redone. All 2"x6" for deck, 4"x4" posts and 2"x4" for rails.		
<b>HYDROLOGY</b>			
<b>Water Velocity:</b>	1.0 m/s	<b>Ice Problem:</b>	NA - Not Applicable
<b>Water Depth:</b>	2.0 m	<b>Scour Problem:</b>	NA - Not Applicable
<b>Waterway:</b>	03 - Not Applicable	<b>Debris Problem:</b>	NA - Not Applicable
<b>Comments:</b>			
<b>REPLACEMENT/REHABILITATION</b>			
<b>Next Rehab. Date:</b>	2017	<b>Replacement Year:</b>	2017
<b>Antic. Rehab. Cost:</b>	\$0	<b>Replacement Cost:</b>	\$0
<b>Recommendations:</b>	Replace with aluminum pipe or multi-plate.		
<b>OBSERVATIONS</b>			
<b>Overall Condition:</b>	P1 - Poor	<b>Requires Further Inspection:</b>	No
<b>Additional Observations:</b>	Abutment # 2 settled, falling. Possible scouring. Tide high - hard to see. Bridge needs to be replaced..		
<b>LEGEND:</b>			
<b>Condition Definitions:</b>
